CHITTENDEN COUNTY REGIONAL PLANNING COMMISSION

SCOPING REPORT

MAIN STREET BRIDGE (US ROUTES 2 & 7) OVER THE WINOOSKI RIVER

May 30, 2019

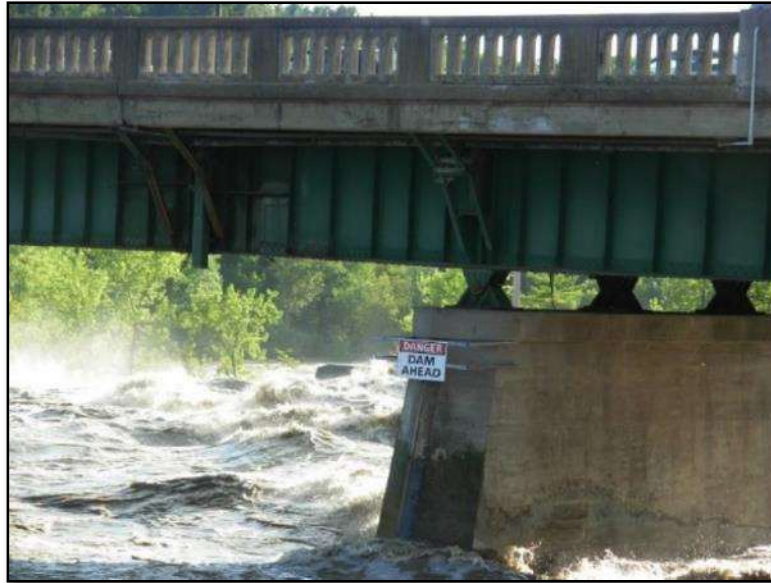
Figure 4 - Hurricane Irene (August 2011) Below the Existing Bridge

The existing bridge structure bottom of steel low point elevation sits approximately 8' above the 100-year storm elevation. The Winooski river upstream and downstream of the existing structure is dam controlled, and therefore the probability of floodwater encroachment on the bottom of the steel beams is considered remote. The current bridge design criteria require a minimum of 1' of clearance between the steel low point and the water surface elevation of the 100-year storm. Any future bridge replacement will meet or exceed the existing low chord elevation. Figure 4 below shows the bridge during the extreme flooding from Hurricane Irene in 2011; note the bridge has substantial clearance above the flood waters.

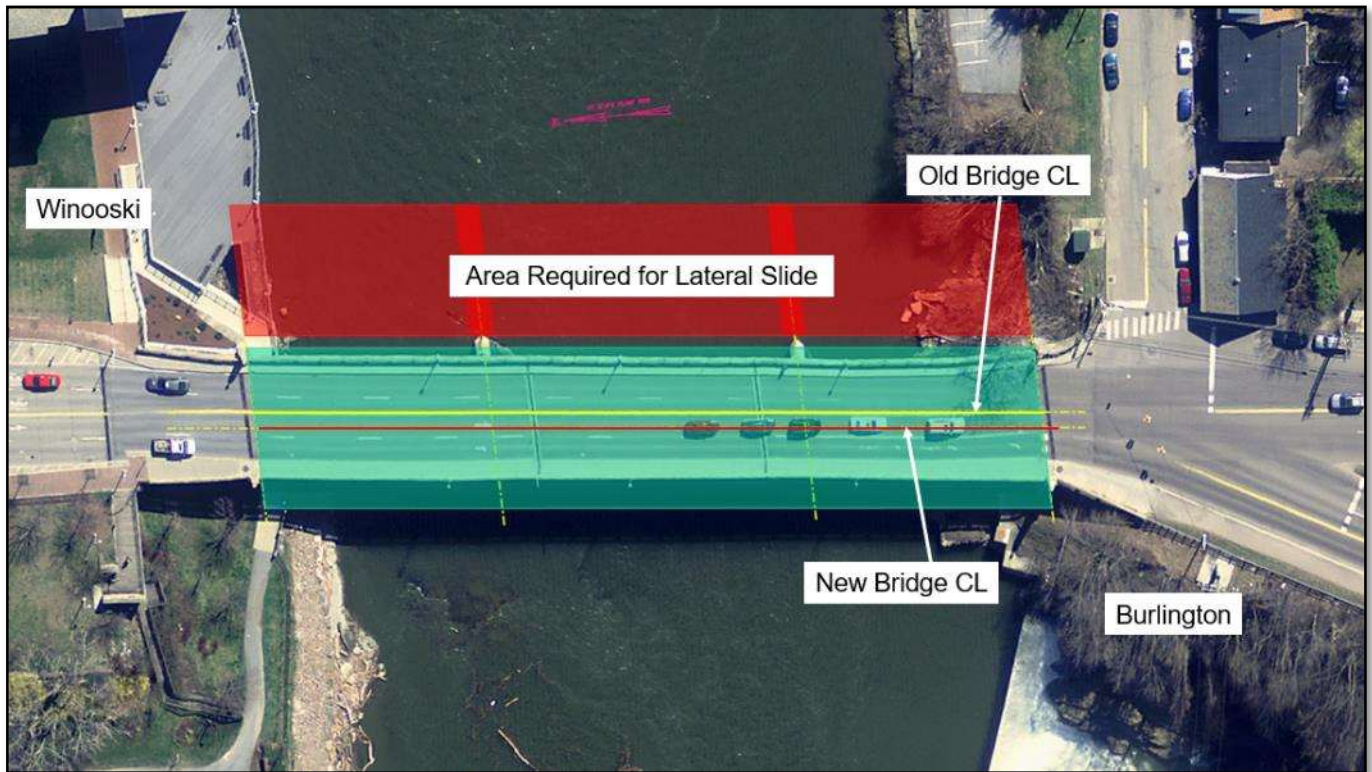
Figure 21 – Alternative 4 Aerial View with Lateral Slide

The use of ABC techniques with Alternative 4 would require a substantial area for the bridge superstructure to be constructed prior to the bridge closure. Due to the proximity of the dam structure, the only available location to construct the bridge would be upstream of the existing bridge (this is why ABC is not possible with the upstream shift of Alternative 3). The approximate location of the area required to construct the bridge is shown in Figure 21 below:

It is anticipated that a portion of the parking lot on Mill Street and the Winooski Riverfront Park at the southeast and northeast corners of the bridge, respectively, would require closure. Both will require reconstruction after the bridge is re-opened to traffic.

The use of ABC techniques would require complete closure of the bridge, which would have large traffic impacts to the surrounding communities. The duration of the bridge closure cannot be determined until final design; however, it is anticipated that a closure duration of 4-6 weeks would be required to remove the old bridge, slide the new bridge into place and reopen the structure to traffic. This is a major reduction in duration of traffic impacts when compared to the estimated construction duration of 2-3 years for conventional construction.

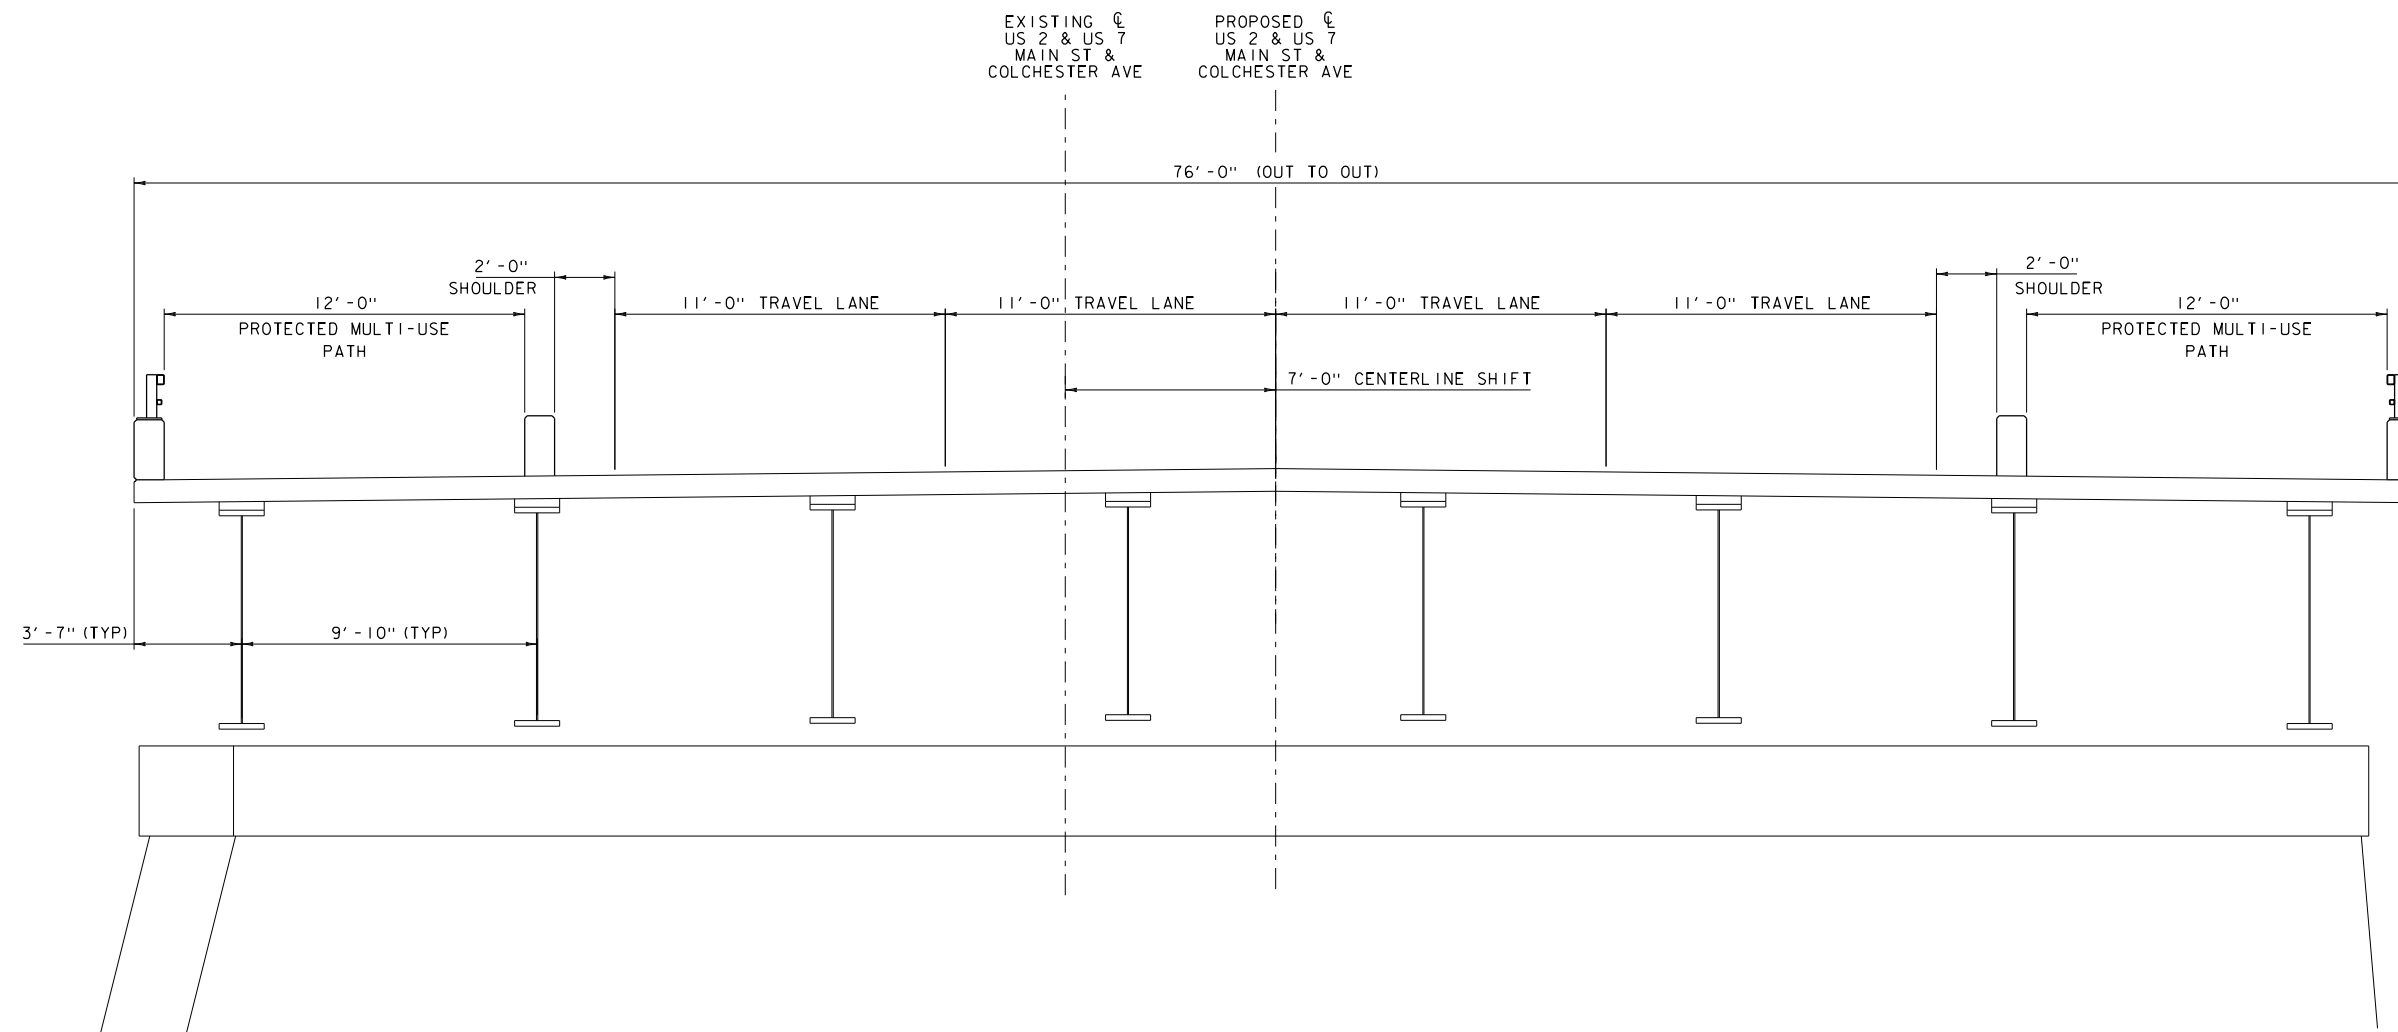
PROJECT NAME: MAIN STREET BRIDGE OVER WINOOSKI RIVER SCOPING STUDY	
PLOT DATE: OCTOBER 1, 2018	DESIGNED BY: D. WHITE
ALTERNATIVE 4 TYPICAL SECTION	DRAWN BY: D. WHITE
	CHECKED BY: D. KULL
	SHEET 4 OF 5

ALTERNATIVE 4 - SUPERSTRUCTURE REPLACEMENT W/ SUBSTRUCTURE WIDENING,
DOWNSTREAM ALIGNMENT SHIFT, AND ALL TRANSPORTATION MODES ON BRIDGE

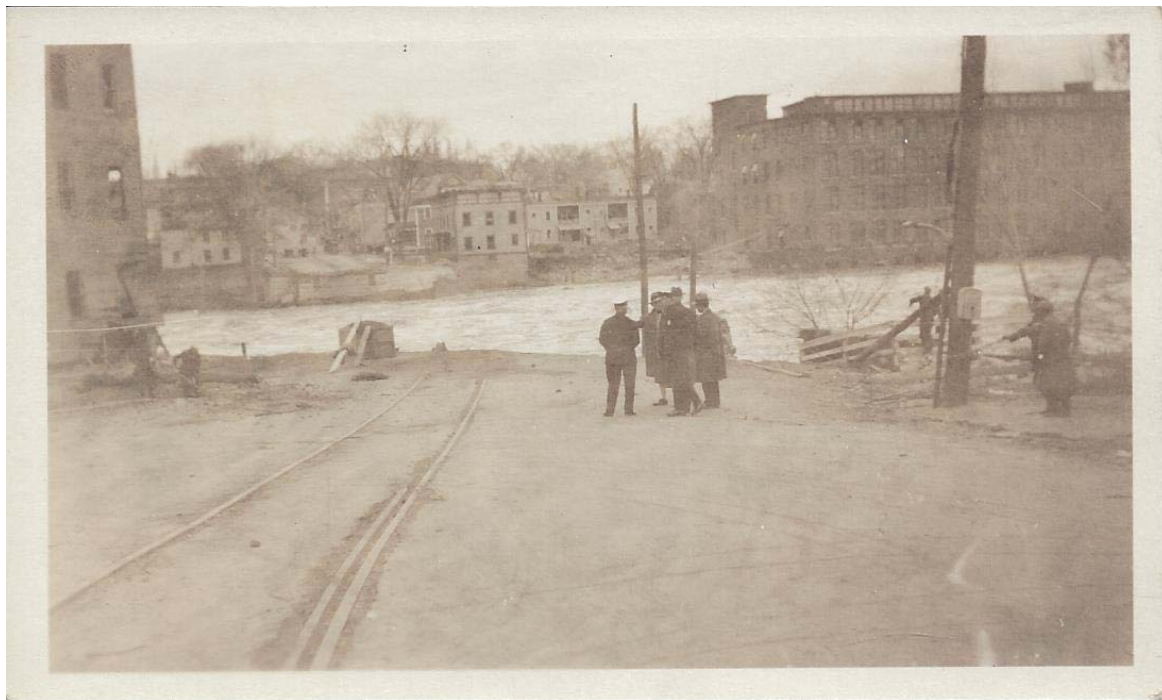
Figure 5. Winooski Bridge destroyed in 1927 flood. A portion of the now-razed Burlington Flouing Company mill is seen at left in this view toward Winooski (Private Collection).

The Winooski Bridge is a poured concrete and steel deck plate girder bridge, constructed in 1928 (Figures 14 thru 17). It replaced an earlier span located along the same alignment, which was destroyed during flooding in 1927. The deck of the present bridge is at a higher elevation; fill at the south approach necessitated the removal of some structures, and resulted in the partial burial of 495-97 Colchester Avenue (Figures 41 and 42).

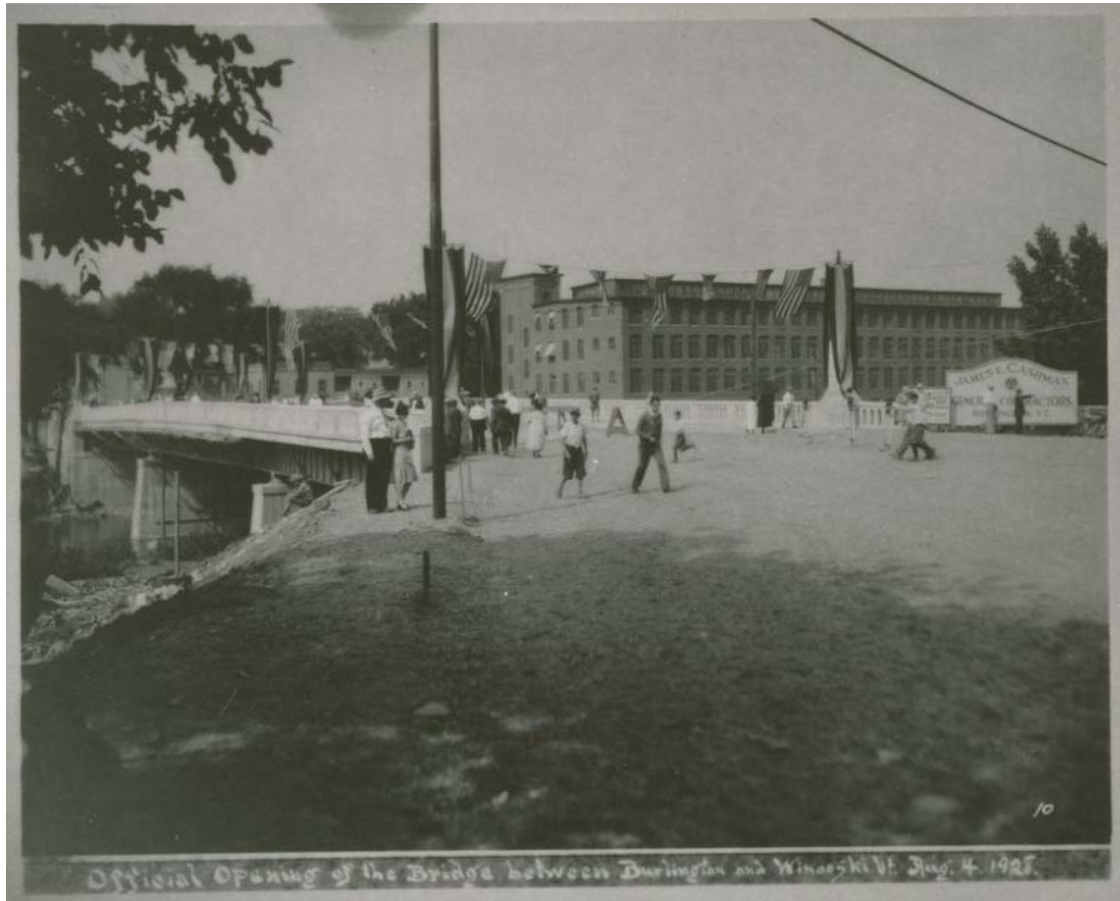
Figure 14. 4 August 1928 opening day of the bridge.

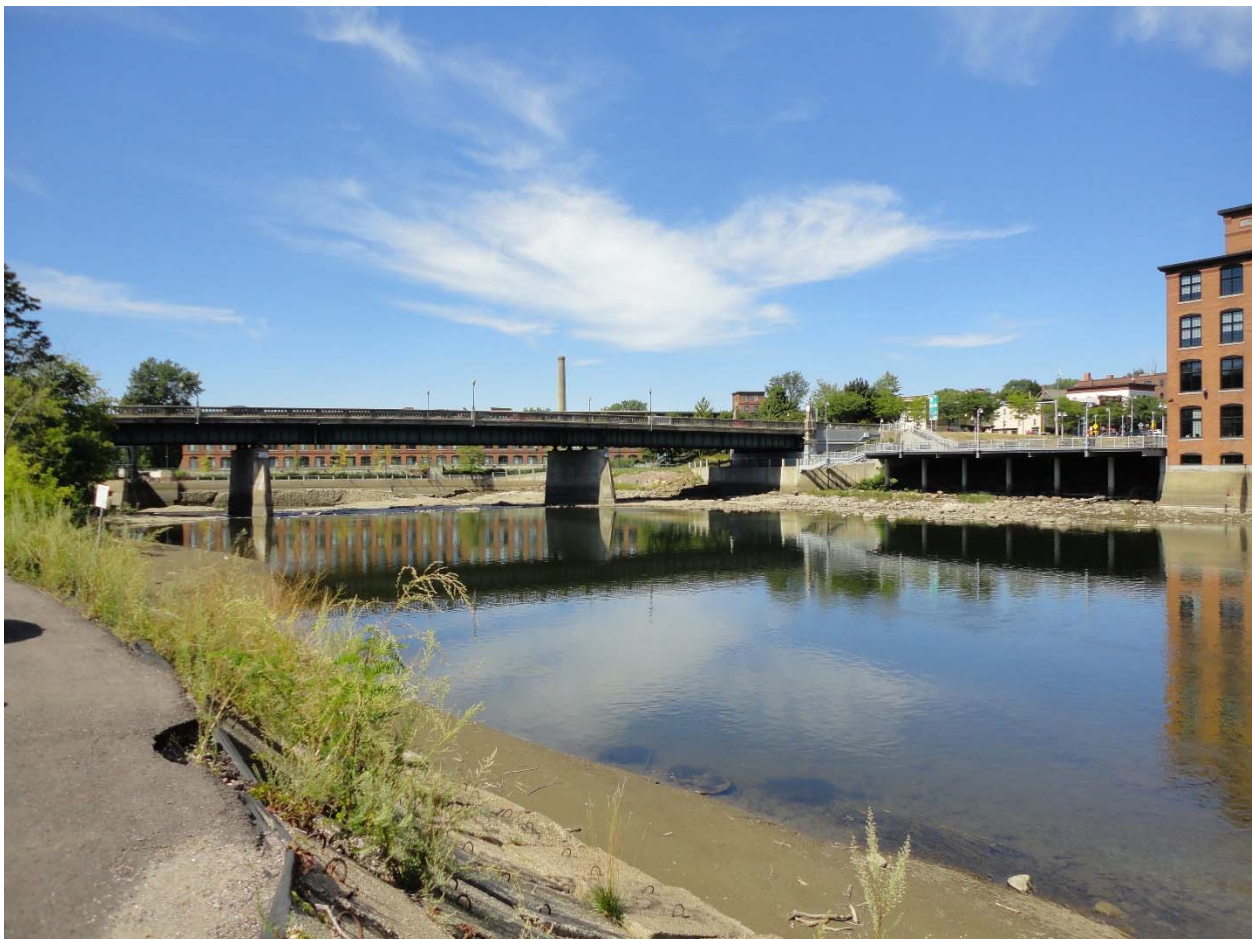
Figure 15. Winooski Bridge, looking northwest, 2016.

The bridge remains essentially as originally constructed, except for the replacement of original standards with modern “cobra headed” lamps, noted in the National Register nomination for the boundary expansion of the Winooski Falls Mill Historic District (Visser and Larson 1993). These were more recently replaced with lamps whose design is more compatible with that of the bridge.

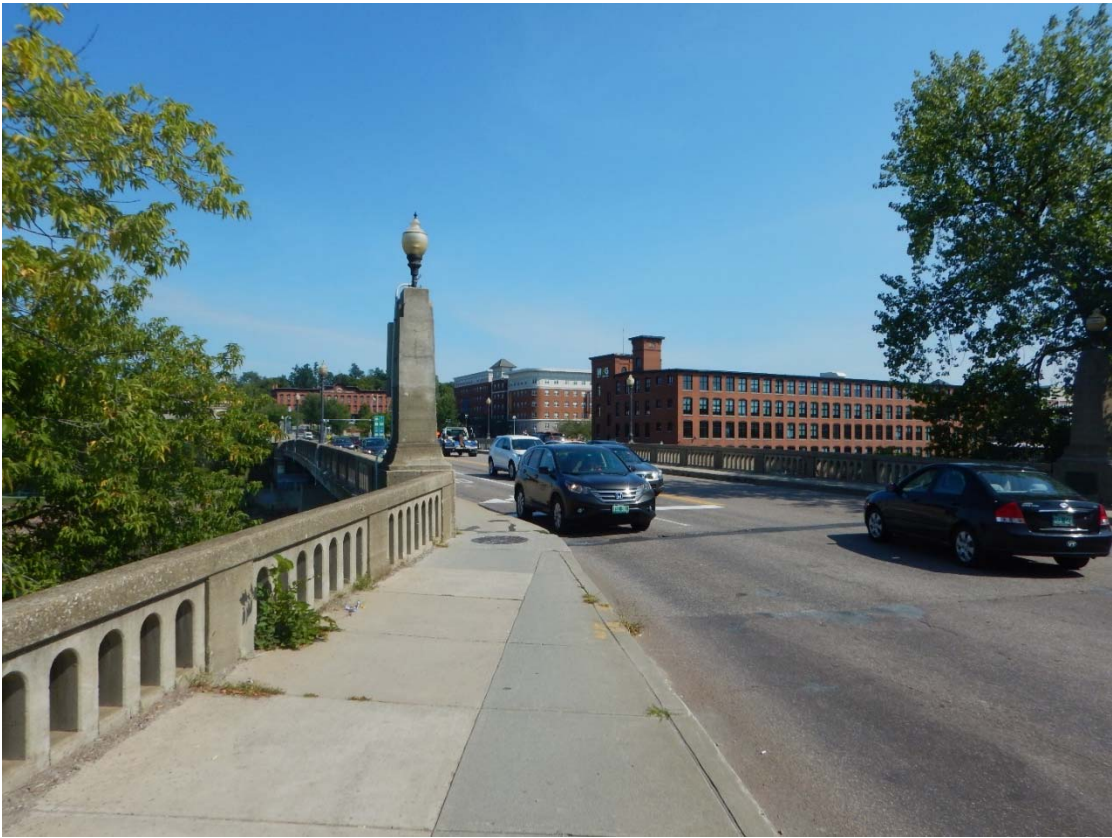
Figure 16. Winooski Bridge, detail looking north showing railing and lamp standard, 2016.

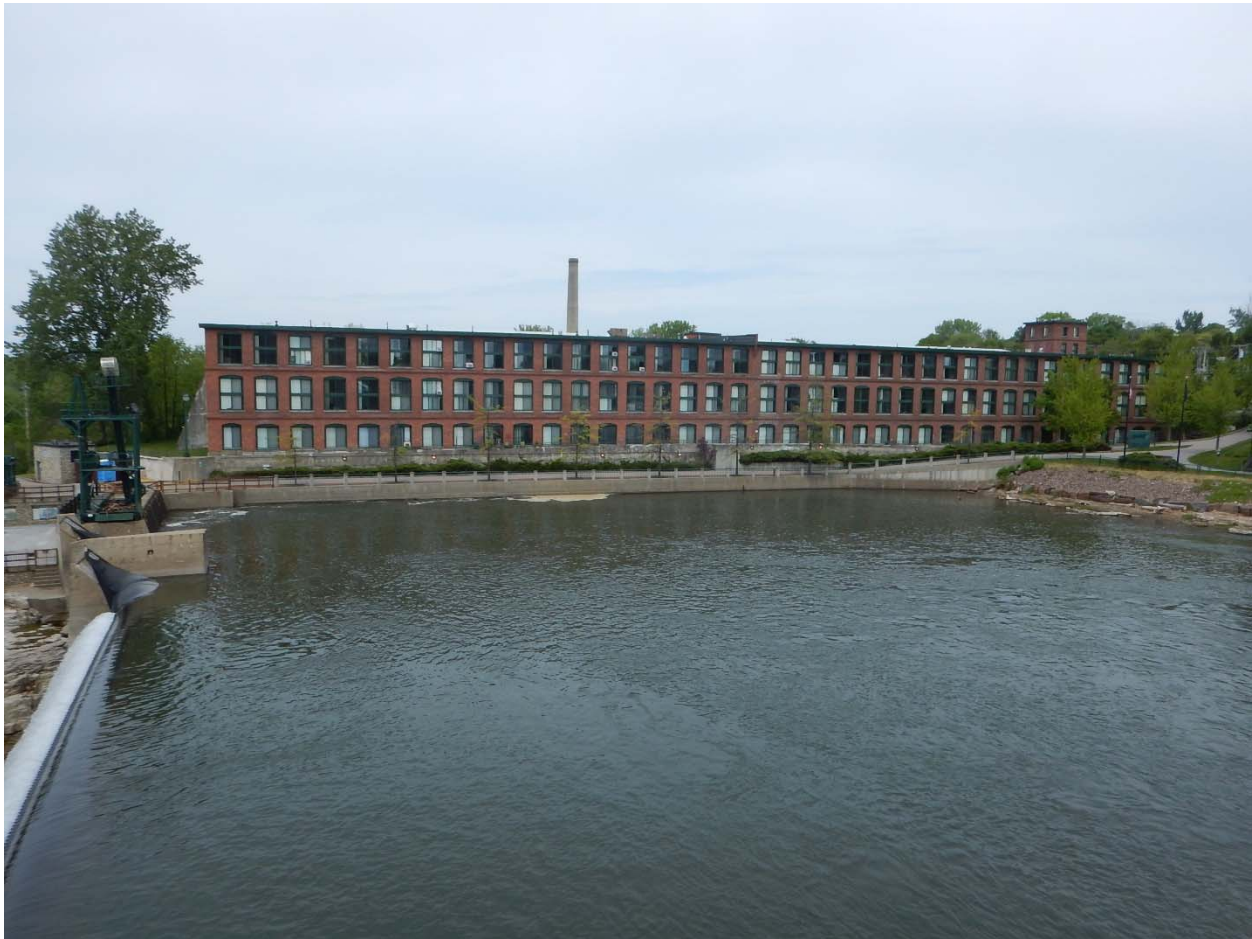
Figure 18. The Colchester Mill, looking west-northwest, 2017.

The Colchester Mill is a three-story tall brick masonry structure, of rectangular plan with a shallow gable roof (Figure 18). It was completed in 1880 as a factory for producing merino goods. In 1902 the building received an addition at its south end, 150 feet in length and spanning a raceway. It was originally a component in the Colchester Millyard, a complex of structures initially constructed c. 1860 (Boyd and Brevoort 1978). At the time the National Register nomination for the Winooski Falls Mill District was completed in 1979, this structure had 20-pane double-hung sash; today these have been replaced with two-over-two sash. Corbelled brick stringcourses indicate each floor level on the otherwise unadorned facades whose closely-spaced windows maximize natural light to the interior. The portion of the building completed in 1880 is 21 bays in width; the 1902 addition is 18 bays wide. Large concrete buttresses have been added to the south gable end wall in an effort to stabilize that part of the building. The slightly banked site results in the northern end of the building having only two stories of brick superstructure, the lower floor at that end of the building is rendered in fieldstone.

Both portions of the Colchester Mill complex have heavy timber internal frames; that of the Worsted Mill is supplemented by a system of metal tie-rods.

A two-story brick masonry office building with four story entrance tower is attached to the north end of the 1880 mill. It is detailed to match that structure, although its double-hung sash are narrower than those used in the mill. The office building has a shallow gable roof; the tower a flat roof. The banked site results in the building being three stories in height at its south end. An arched entrance gives access to the complex from West Canal Street, which is today occupied by a health club and professional offices.

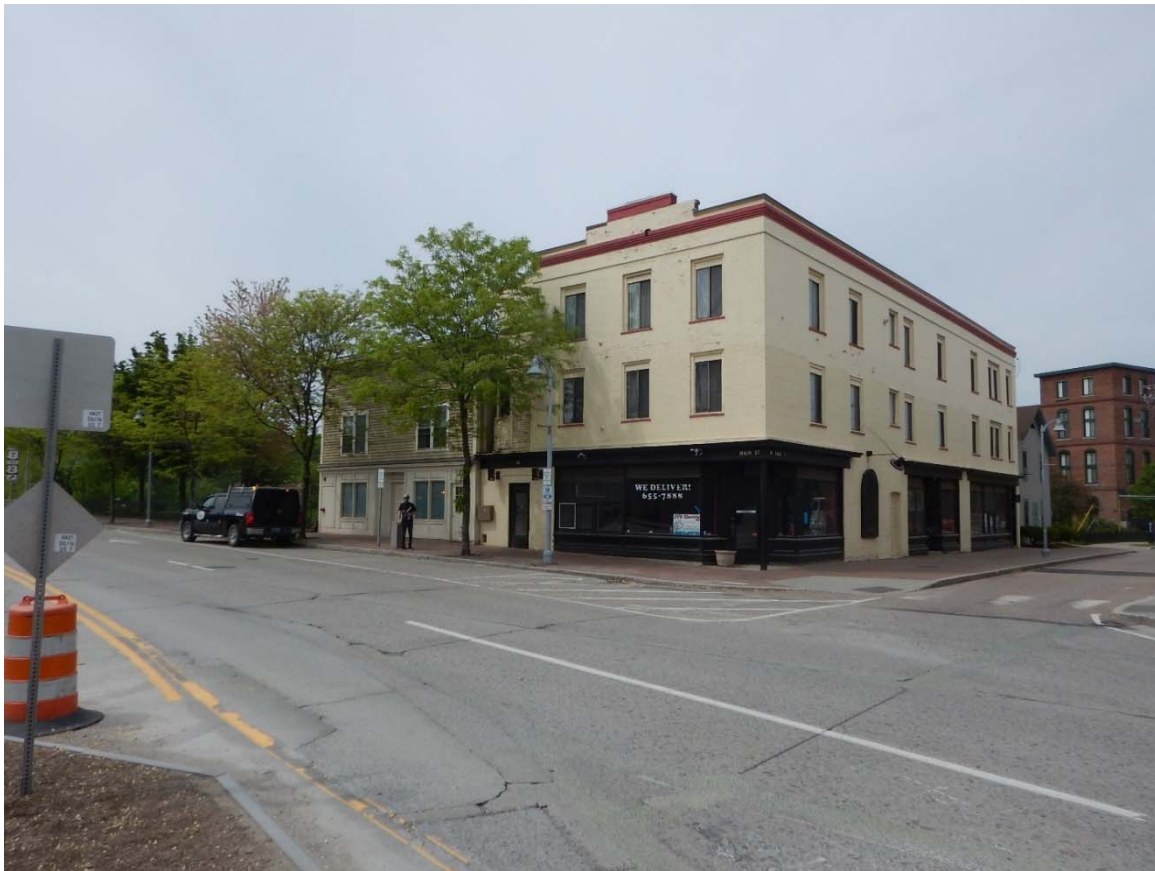
Figure 20. View looking west-southwest at 22 Main Street, 2016.

A three-story brick masonry building of three stories with a flat roof, and of rectangular plan (Figure 20). Originally built c. 1845 as a 2 ½ story Greek Revival commercial block with a gable facing Main Street, the third floor was added c. 1890. In 1889 this structure was occupied as a billiards hall (Map 5).

Windows of the upper floors have jack arches and are set within a wall laid in common bond. Throughout, windows have been replaced with sliding two-part sash which are set into reduced openings. An entablature and cornice are formed by corbeled brick. A stepped parapet wall caps the Main Street elevation.

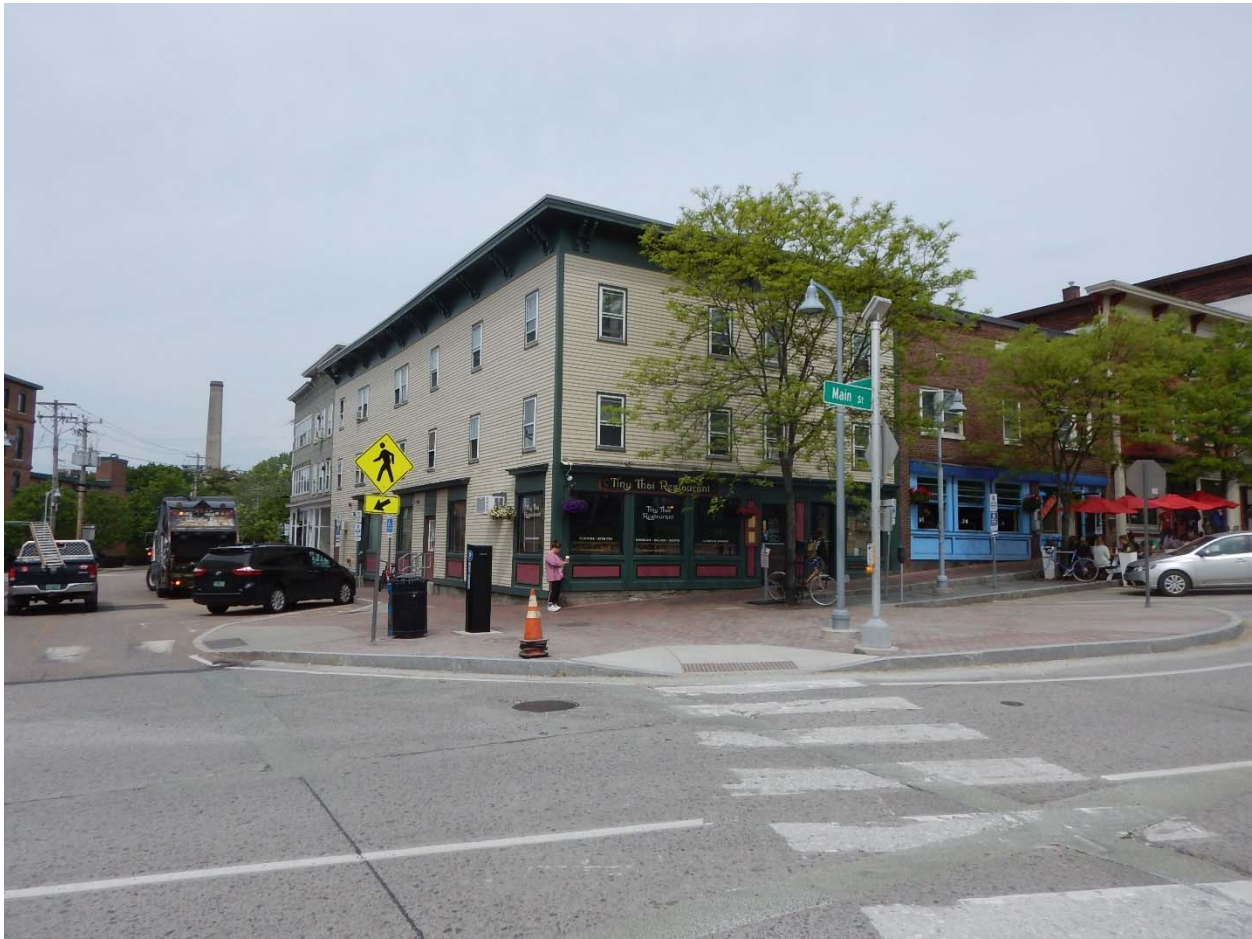
Figure 22. View looking northwest at 24 Main Street, 2017.

Alterations undertaken subsequent to 1979 included a redesign of the storefront on the Main Street elevation, and addition of two smaller storefronts on the West Canal Street face of the building. Today a storefront with paneled bases, plate glass windows and a recessed entrance extends across the Main Street elevation; the cornice seen in the 1979 photograph (Figure 21) appears to have been retained, and was replicated for new storefronts inserted on the West Canal Street elevation, and which also replicate the details used in the design of the new Main Street shop front (Figure 22).

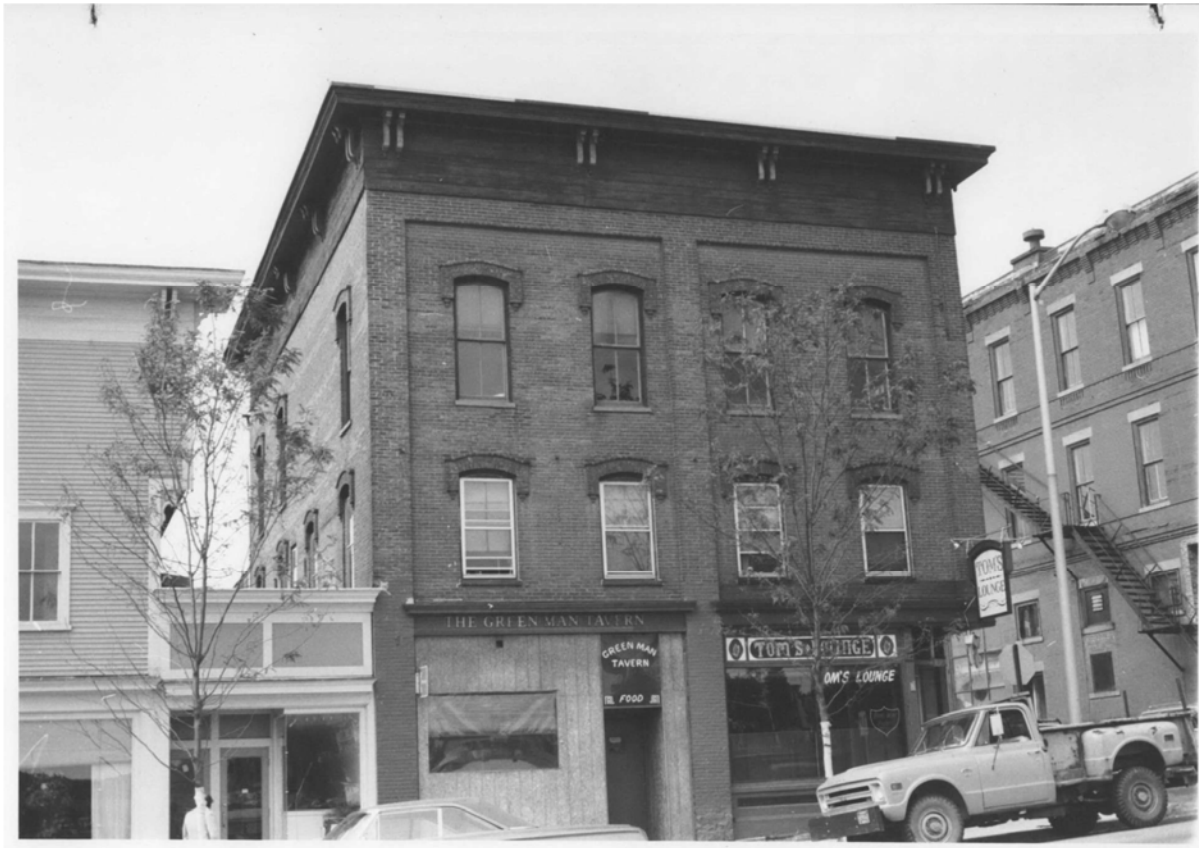
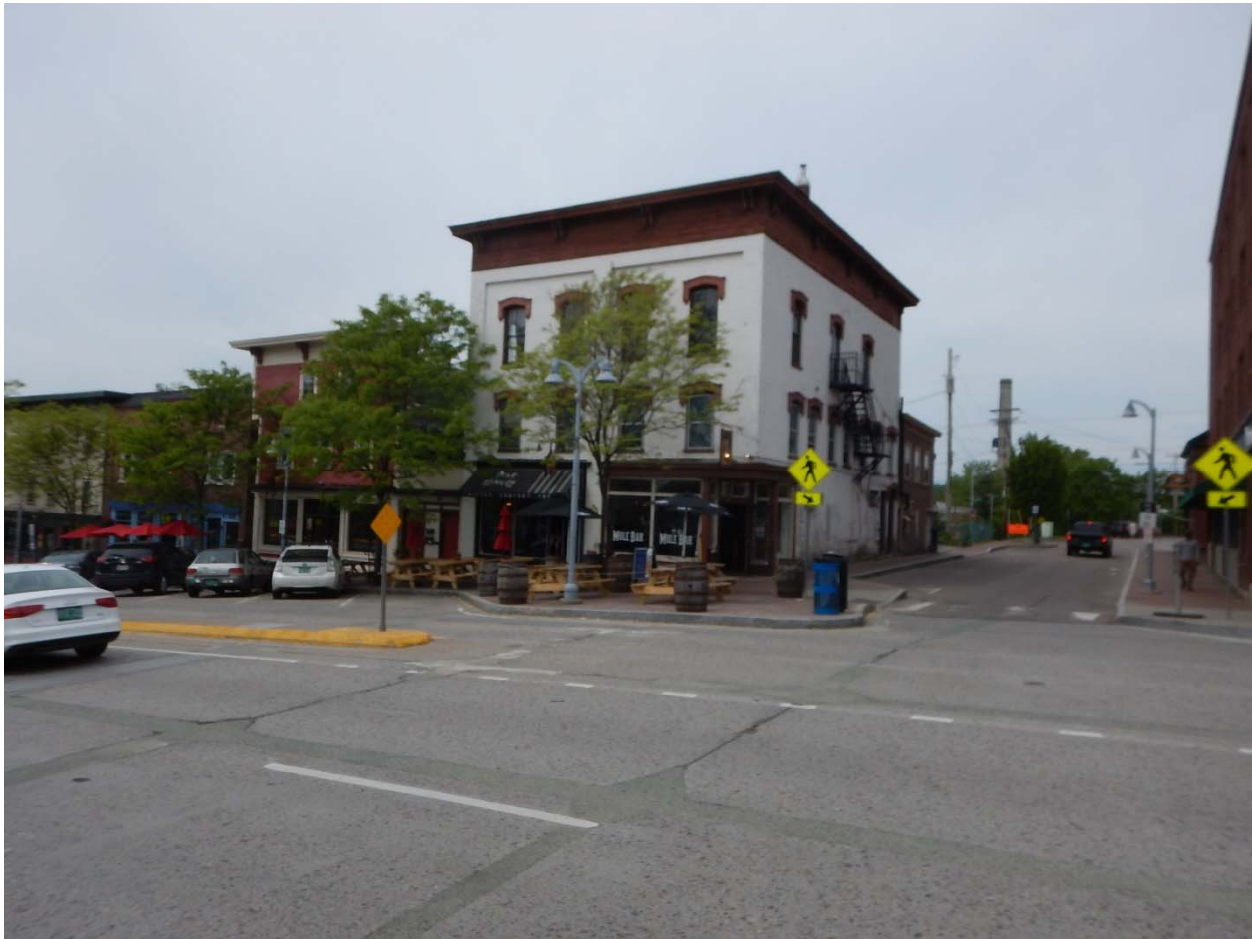
Figure 26. 36-38 Main Street, looking west-northwest, in 1979 (Page 1979).

Figure 27. 36-38 Main Street, looking southwest, 2017.

A three-story brick masonry block constructed c. 1880 at the height of Winooski's commercial success (Figures 26 and 27). This structure presents a four bay wide façade on Main Street, above a pair of storefronts at the first floor level. The southern of the two storefronts was constructed after 1979; the other, occupying the corner, appears to date to the early 20th century and includes a recessed corner entrance and transomed plate glass display windows over paneled bases. The upper floors of the Main Street elevation are vertically subdivided by recessed panels, each of which contains two bays of fenestration, and extend from the second to the third floors. Windows on each of the elevations have corbelled brick arched lintels and consist of two-over-two double-hung sash. A deep entablature with moulded cornice supported on paired brackets caps all faces of the building except the west elevation.

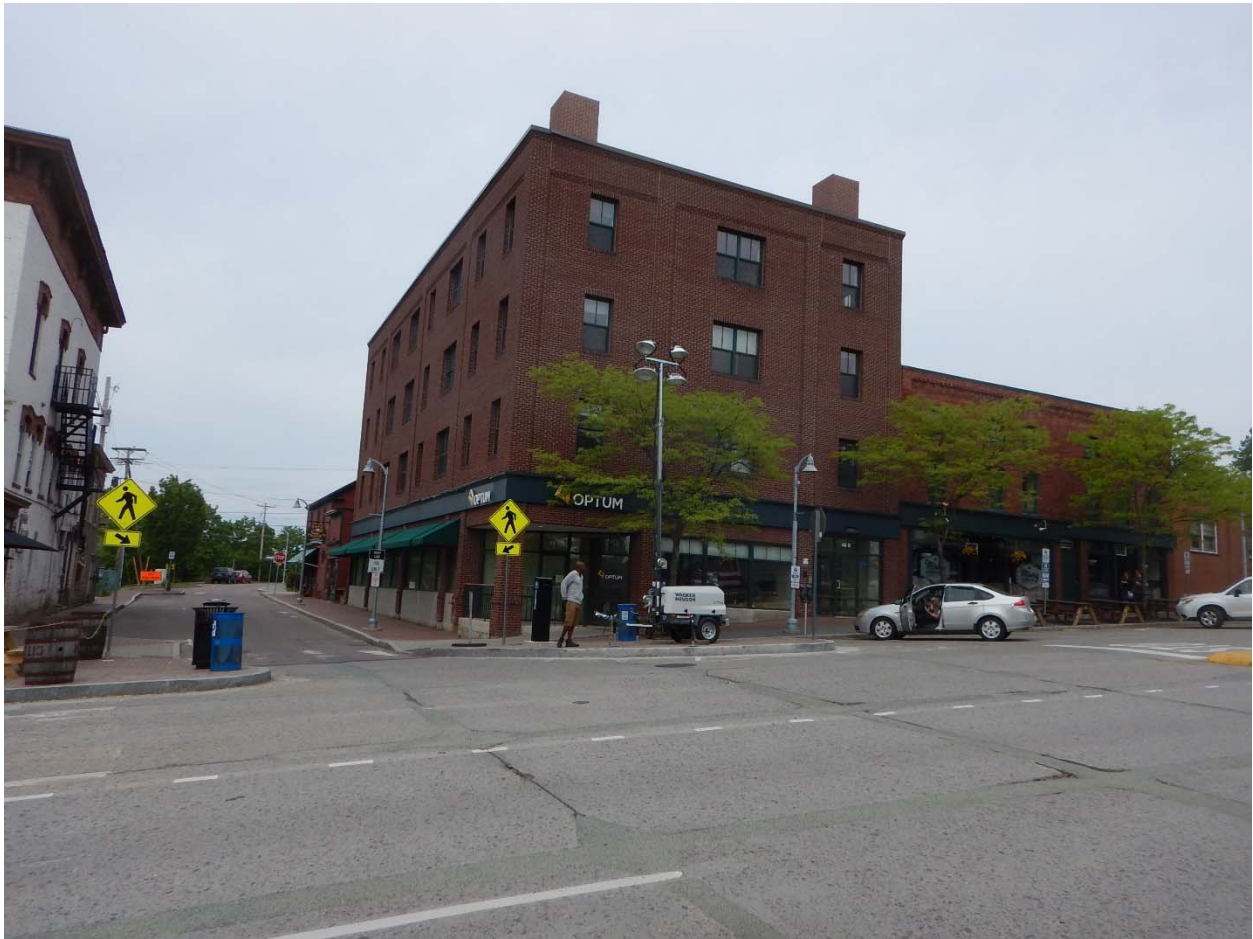
Figure 28. 40 Main Street, looking west-northwest, 2017.

A four-story brick masonry mixed-use building, having retail stores on the first floor (Figure 28). This structure was built c. 1990 and replaces a late-19th Vermont State Register-listed building of similar size which formerly occupied the site. Fenestration and bay widths are irregularly spaced; the design of the elevations of this building take their inspiration from the nearby 36-38 Main Street, which features an elevation with recessed panels similar to those used on both the Main Street and West Center Street elevations of this building. Windows are two-over one double-hung sash, a number of which are conjoined in pairs.

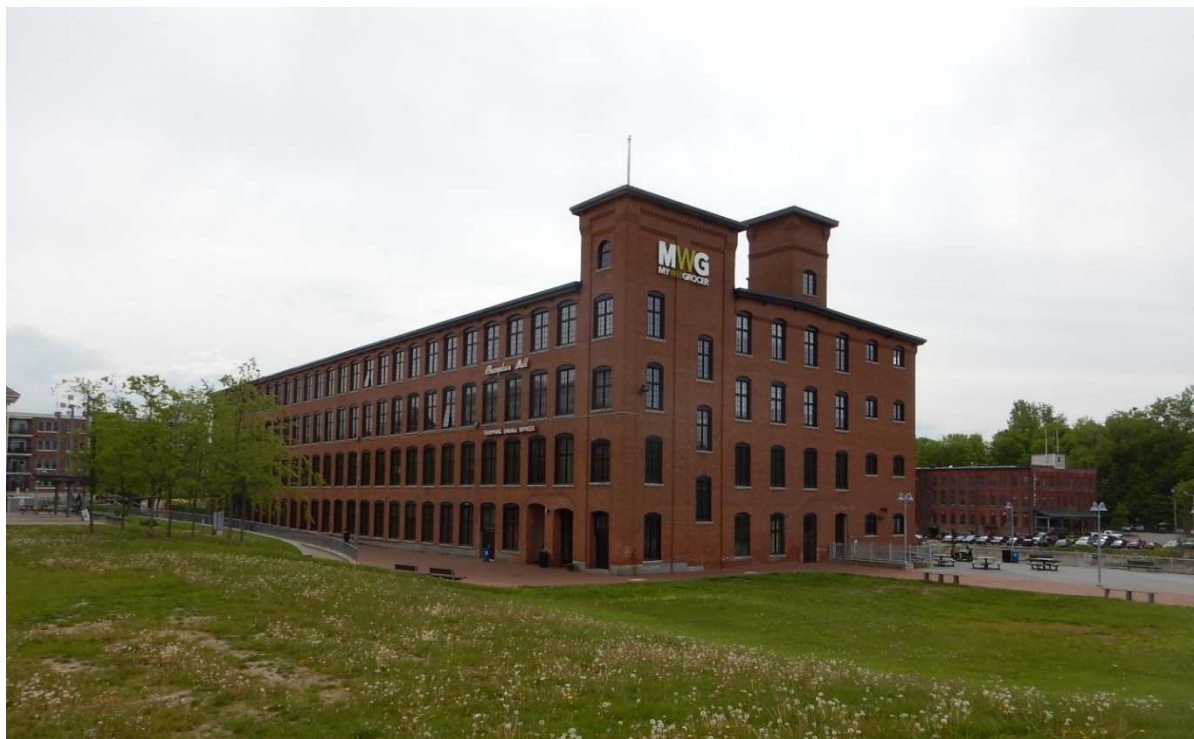
Figure 40. View looking southeast at the Champlain Mill, 2017.

The Champlain Mill is a four-story brick masonry industrial building 28 bays (280 feet) long on its north and south faces and approximately 100 feet wide across the eight bays of its east and west end walls (Figure 40). The building has a nearly-flat gabled roof. A monitor, lit on north and south faces by a continuous range of windows was an original feature of the building and was removed in 1980.

set within segmental arches. Each window is centrally divided by a heavy mullion and each has a transom bar approximately one-third of the distance from the top. Each window thus contains a total of 42 panes. Basement windows on the river façade are shortened due to the foundation, and consist of only the 12 panes above the transom bar (Boyd and Brevoort 1978).

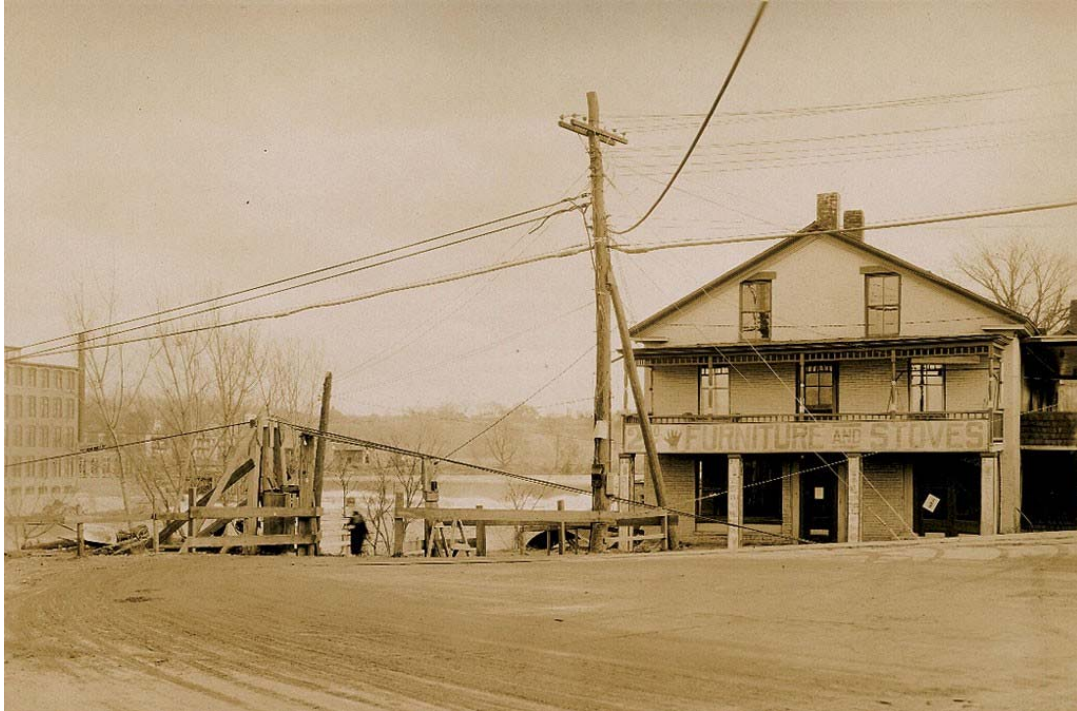
Figure 41. View looking east, showing 495-97 Colchester Avenue previous to 1927.

Alterations to the topography undertaken to create an approach to the Winooski Bridge in 1928 buried the first floor of this structure, reducing its exterior height to one-and-a-half stories (Figure 41). During 2014-16 the present owner undertook a project to jack up the upper floor of the structure, disassemble the buried first floor of this building, construct a new foundation extending up to the present elevation of Colchester Avenue, and insert a new first floor between the two (Figure 42). The goal has been to return the building essentially to its appearance and relationship to the surrounding topography as it was in the 19th century. To this end, the fenestration pattern of the original first floor has been replicated in the remodeled building, and the original materials have been used wherever possible. This work is now complete (Figure 43).

In place of display windows visible in 20th century photographs of the Colchester Avenue elevation (Figure 41), a central door flanked by single windows has been installed in the new first floor. These windows are double-hung 6-over-six sash; the remainder of the windows in the building are also double-hung, but are 2-over-2 sash. Divisions of the interior created to convert the building into apartments have been removed, leaving an open plan. It is anticipated that the building will be used for commercial purposes and office space.

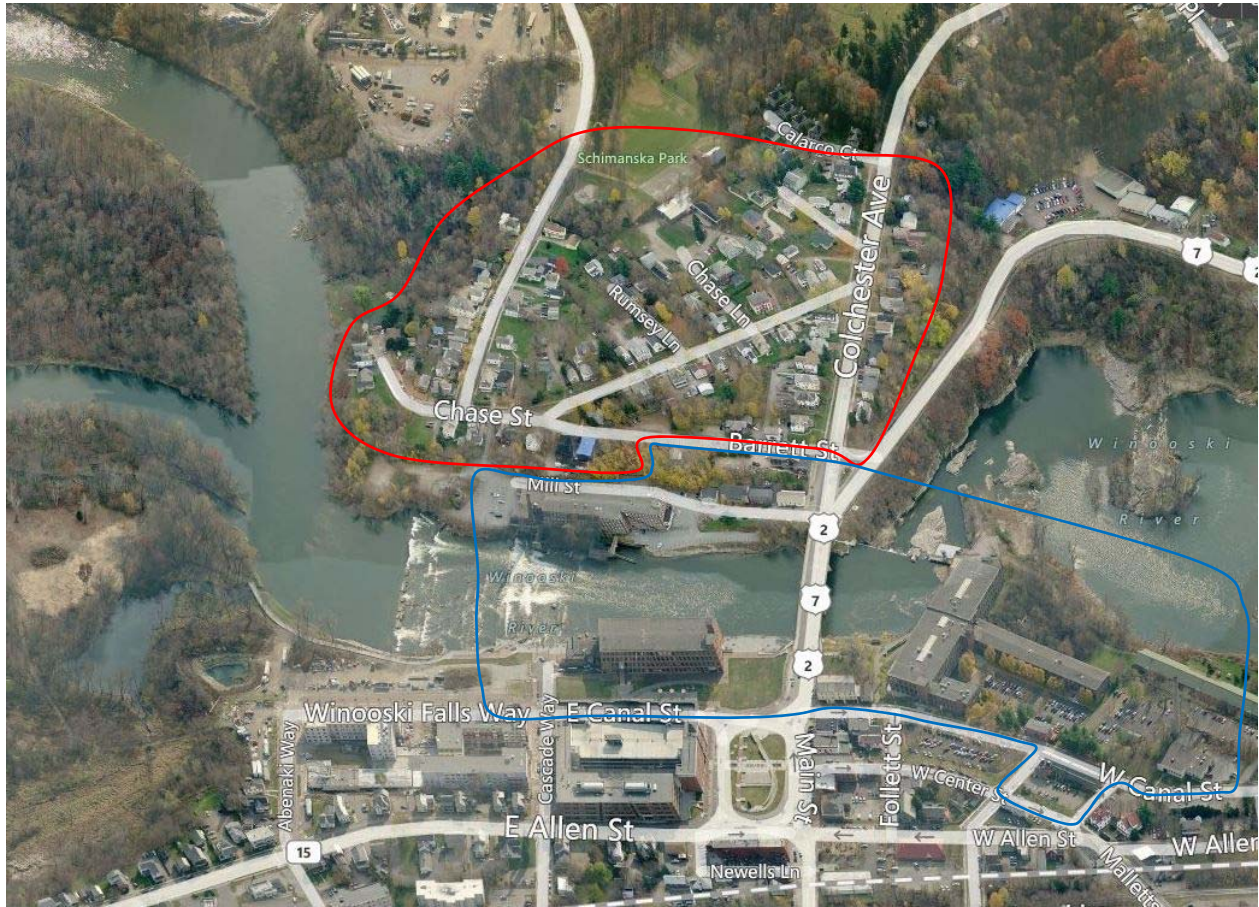
Figure 53. Aerial view looking south, showing the boundaries of a proposed expansion of the Winooski Falls Mill Historic District, in red. The southern edge of the already-listed Winooski Falls Mill Historic District is indicated with a blue outline. A potential northern expansion of the Winooski Falls Mill Historic District would encompass the parts of the city visible in the bottom of this image.

A northern expansion of the Winooski Falls Mill Historic District would also logically take in similar residential, commercial and institutional structures located in downtown Winooski constructed up to c. 1940, which marked the end of the period of prosperity of the mill industry in the region. Such an expansion would potentially take in much of the downtown core of the City of Winooski, and include adjacent residential neighborhoods. A conservative northern boundary of such an expansion might follow the east-west course of the railroad tracks, just south of Railroad Lane; its configuration within that area would need to take into consideration the large amount of new construction that has occurred in downtown Winooski, greatly altering just about every streetscape as a result. Such a boundary expansion would, however, provide an opportunity to include some of the oldest standing structures in the city within an historic district, including the stone house at 73 East Allen Street, reputedly built in 1790.

A more extensive district would include areas as far north as Pine Street, in the northwest, and LaFountain Street in the northeast portion of the city, taking in residential neighborhoods constructed in the early 20th century. However, such a district would better constitute a separate “Winooski Historic District” and it would extend southward to be contiguous with the Winooski Falls Mill Historic District. Because of the potential extent of this district, its exact outlines have not been determined to any greater detail.
