Burlington-Winooski BF RAIZ(2)

Bridge No. 150

On behalf of the Vermont Agency of Transportation (“VTrans”), VHB has prepared this Historic Resources Identification Report (“report”) as part of the regulatory planning process for Burlington-Winooski BF RAIZ(2) (“Project”). This report documents resources protected under Section 106 of the National Historic Preservation Act (“Section 106” and “NHPA”), (36 CFR 800 / 16 U.S.C. 470) and Section 4(f) of the Department of Transportation Act (“Section 4(f)”), 23 C.F.R. 774 / 49 U.S. 303.

The Project proposes to remove and replace the Winooski Bridge (Bridge No. 150), which carries US Route 2 / US Route 7 over the Winooski River between Burlington and Winooski, VT. Also called the “Main Street Bridge”, this is the only crossing over the Winooski River that connects the cities. The new bridge is proposed for the same alignment, but wider. The current bridge has narrow travel lanes, no shoulders, and narrow sidewalks. For this reason, potential indirect impacts of this changed on adjacent resources must be considered, as well as the impacts during construction.

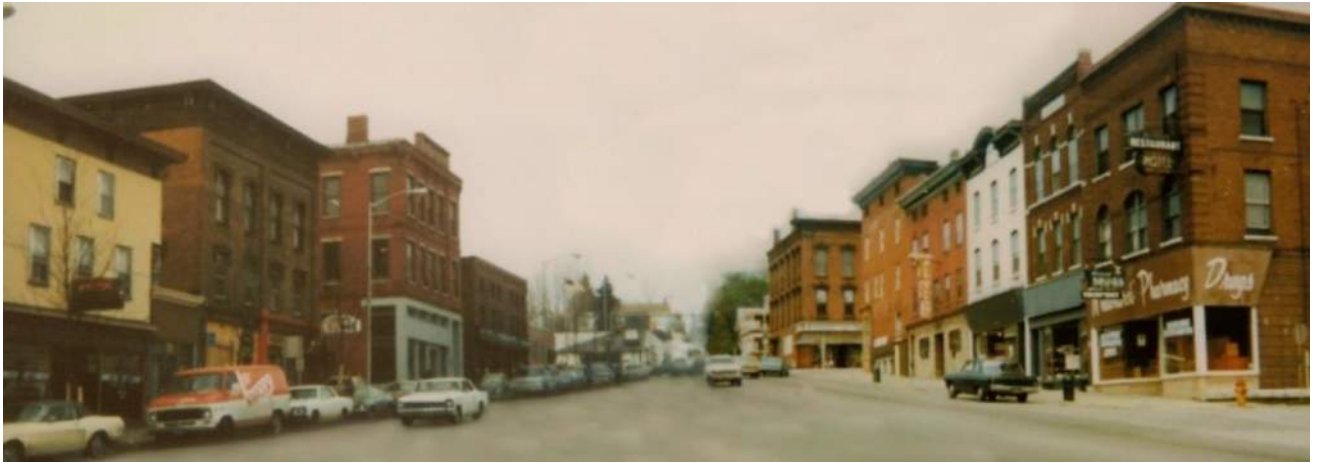
Figure 2: Winooski Main Street in 1973 prior to the urban renewal project. The buildings on the east side of Main Street (at right in the image) were demolished soon after this photograph was taken.⁸

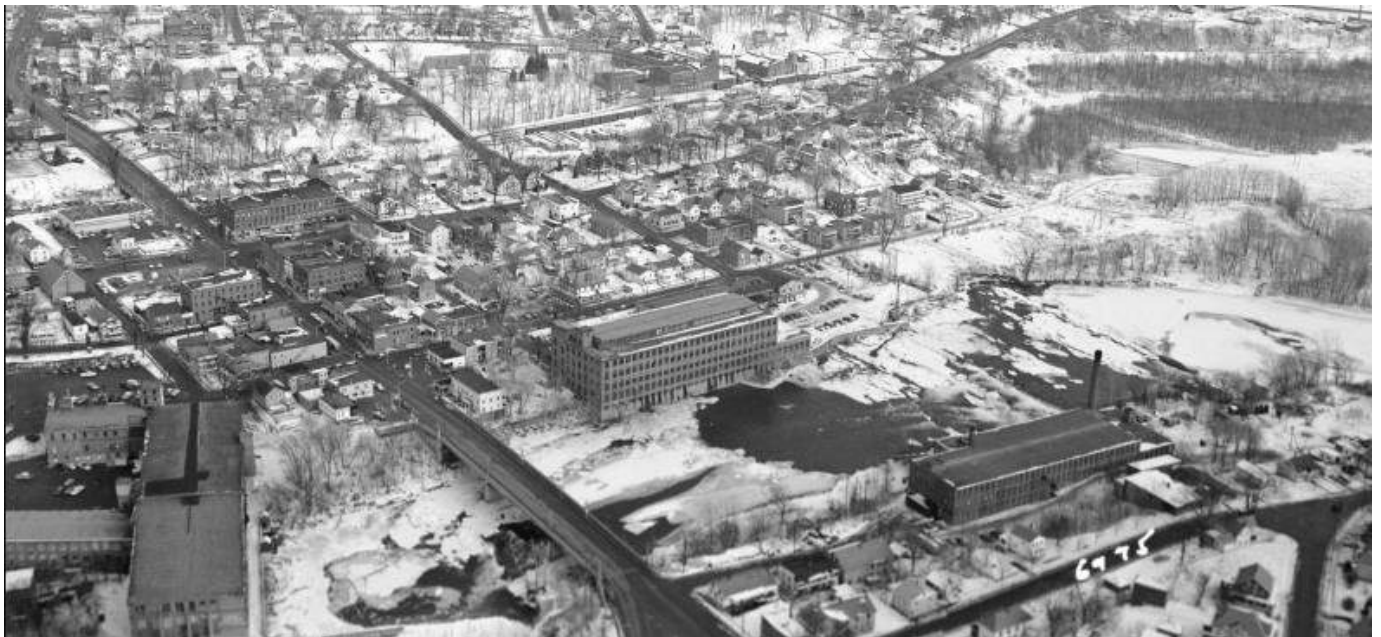
Figure 5: Aerial image from 1963 showing the Winooski Bridge and its surrounding environment.¹²

and in 1903 a new hostelry, the Brunswick Hotel, was built on the lot formerly occupied by the Stevens House. Contemporaneously, a group of three wood frame, two story tenement houses were built just south of new hotel. The tenement houses are visible in Figures 5 and 11. In 1930, the Brunswick Hotel was moved to a different lot on Canal Street and in its place a filling station was erected.¹⁴ The tenement houses are still visible in aerial imagery from 1963 however aerial imagery completed in 1984 shows the buildings all removed with greenery in their place. It is likely that the filling station and tenements near the Champlain Mill were demolished as part of Winooski's urban renewal project in 1973.

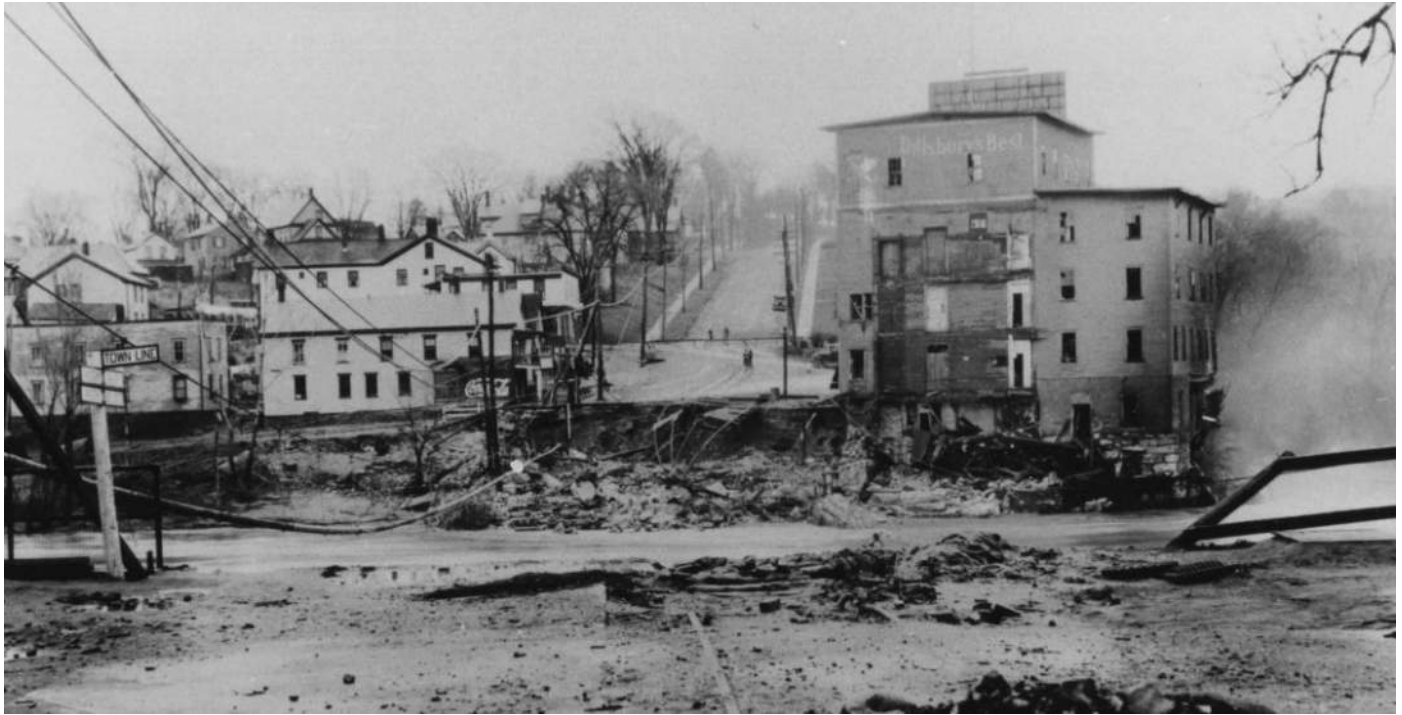
Figure 6: The Burlington Flouring Mill in the aftermath of the November 4, 1927, flood. The floodwaters severely damaged the building along with much of downtown Winooski and the OEE. To the left, Mill Street in the OEE is visible.¹⁷

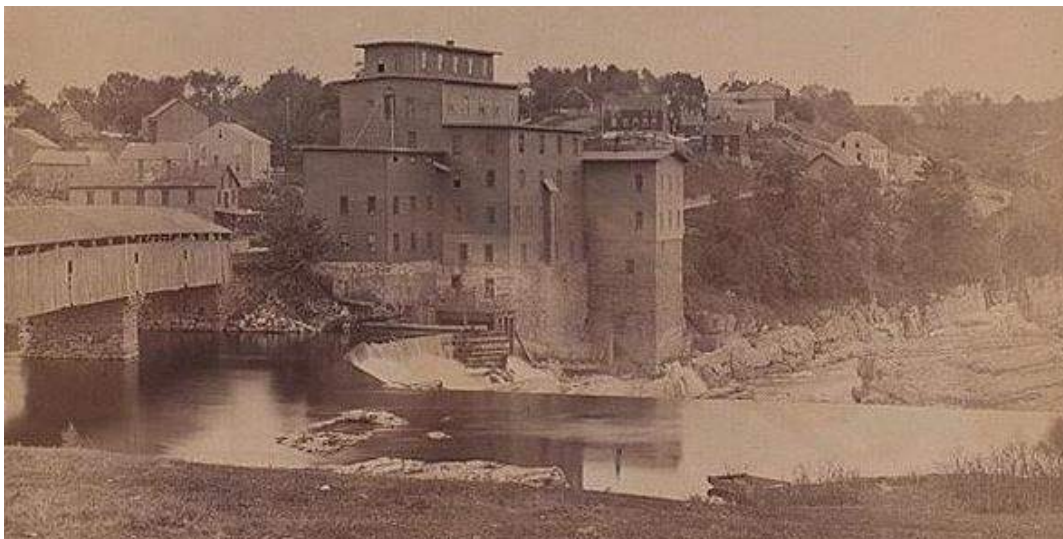
Figure 9: Photo of the Flouring mills c. 1860 showing an early covered bridge which spanned the Winooski River. This photo looks southwest. The OEE neighborhood is also visible.

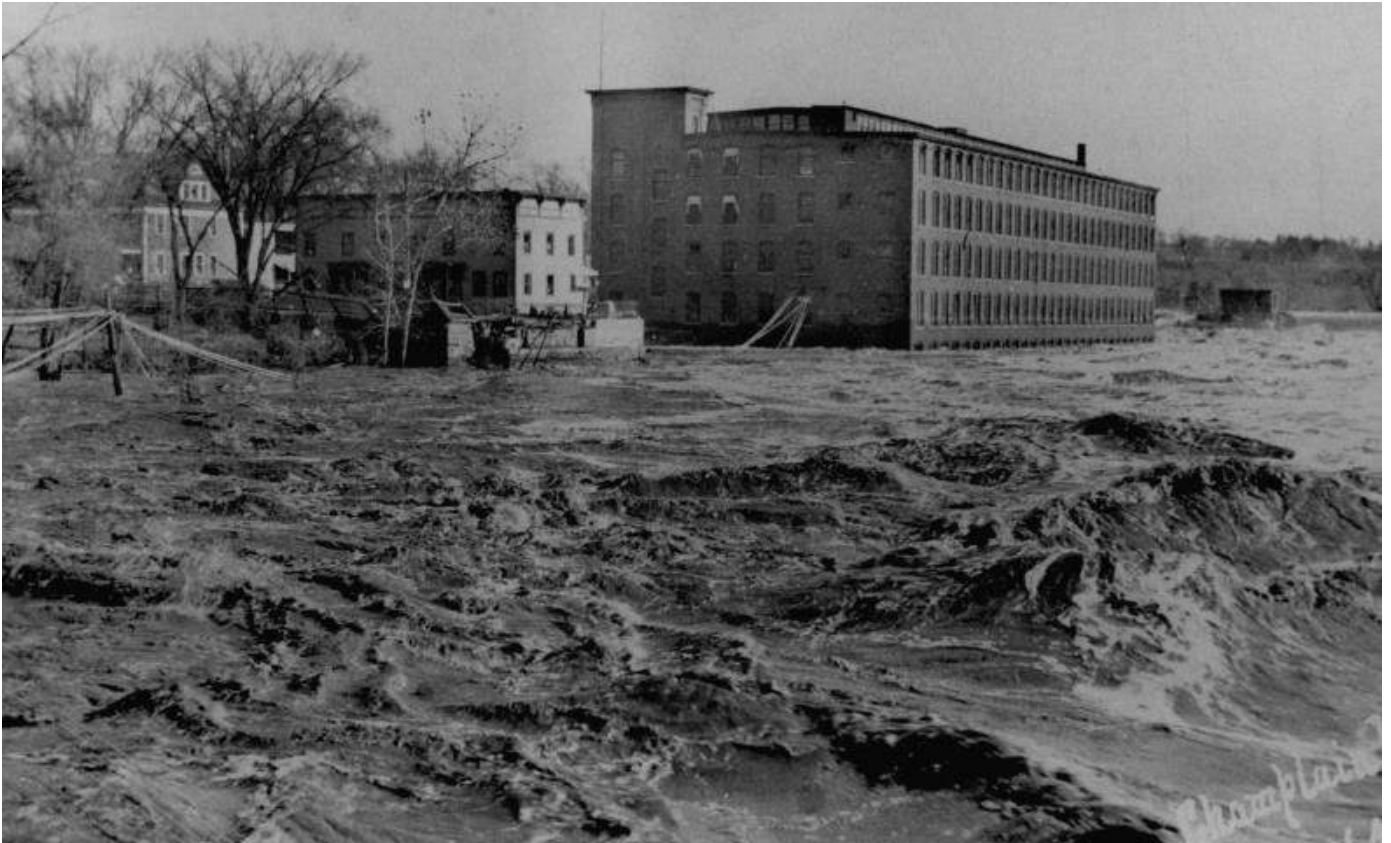
Figure 11: Flooding from the Vermont Flood of 1927. Water from the flood destroyed the bridge connecting Winooski and Burlington and flooded the lower level of the Champlain Mill. The mill buildings in Winooski and the OEE were significantly damaged by the floodwaters.²⁴

The flood also caused significant damage to the mill buildings, devastating the economy of Winooski, and resulted in a temporary decline in development. The city barely had enough time to rebuild after the flood when the stock market crashed in 1929 resulting in the Great Depression. The mills struggled during this time, and unemployment in Winooski was rampant. Owing to the flood and the Great Depression, the mills in Winooski and the OEE did not experience sustained prosperity until World War II.

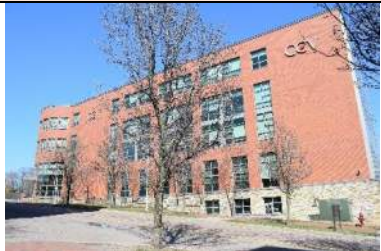
1	1 Abenaki Way	2009	Community College of Vermont. Large, 4-story, brick façade academic building with basement story on west side and rear. Large spans of windows, brick veneer, stone veneer foundation.	N/A	Ineligible due to age
2

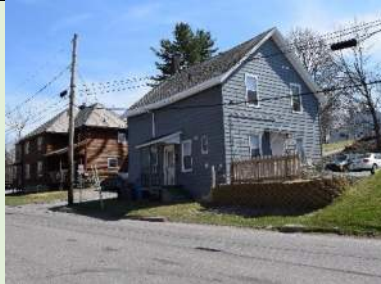
3	9-11 Barrett St	c. 1880	1.5 story, gable roof, wood-frame, 4x3 bay, eaves front residence with central entrance on eaves side and additional centered side elevation on a parged concrete foundation. Details include overhanging eaves, interior end chimney, slate roof, aluminum siding, replacement and aluminum storm windows.	N/A	Fenestration and materials have been somewhat altered. Retains integrity of setting, location, design, workmanship, feeling, association. Eligible as contributing resource to potential Old East End ("OEE") HD.

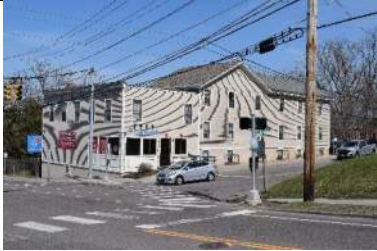
4	10 Barrett St <i>(address is at rear building; front is 485 Colchester Ave)</i>	1790	2-story, cross gabled, wood frame, 6x3 bay, residence with entry on rear elevation. Building on elevated concrete foundation. Details include slate roof, original wood clapboard, replacement windows.	6-10 Barrett St, Burlington (SR) NR #20 Winooski Falls Mill HD	Since its 1993 listing, the front building has been changed (materials - siding, windows – and fenestration). The large central chimney has been removed. The building has lost integrity of materials, design, workmanship, and feeling. It is recommended to remove this property from the Winooski Falls Mill Historic District.
5

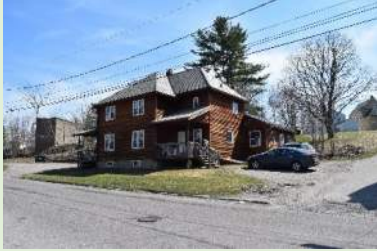
5	17-19-21 Barrett St	c. 1900	2-story, wood frame, hipped roof, 4x3 bay duplex residence with entries on the recessed façade bays. Building sits on concrete block foundation and has rear shed roof addition. Details include slate roof, wood clapboard, replacement windows, façade porches with shed standing seam metal roofs.	N/A	Retains integrity of setting, location, materials, design, feeling, and association. Eligible as contributing resource to potential OEE HD.

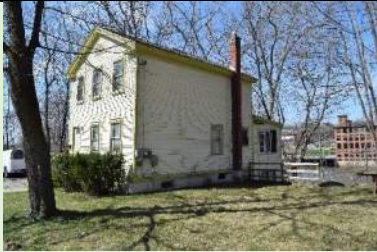
6	32 Barrett St	1853	2-story, 3x1 bay, gable front Greek Revival with clapboard siding, return cornices, cornerboards, replacement windows, exterior chimney, and rear 1-story shed roof addition with basement level.	NR #16 Winooski Falls Mill HD	Minor changes have occurred since the NR such as removal of shutter and window replacements. Overall retains integrity of setting, location, materials, design, workmanship, feeling, association. Remains eligible in Winooski Falls Mill HD.
7

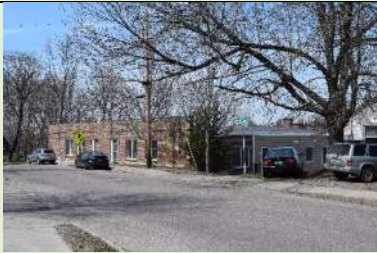
7, 8	50 Barrett St	1884; 1954	1 story, flat roofed, wood frame 8x7 bay apartment building with brick veneer façade and false front parapet. Center bay entries and entries on side elevation. Details include concrete belt course, brick windowsills, and decorative brickwork on façade. Built as a warehouse by the Cotton Mill, later used as Vermont's first radio station and a television studio for WMVT.	N/A	Building has lost its original appearance as a warehouse however it retains features and elements congruous with its conversion to a radio station/television studio. Retains integrity of setting, location, materials, design, workmanship, feeling, association. Eligible under Criterion A for its relationship to the introduction of radio and television to Vermont.

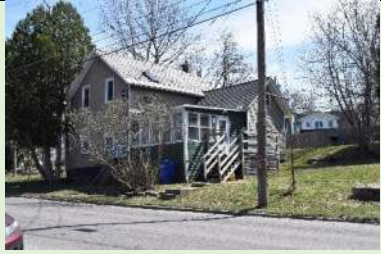
9, 10	51 Barrett St	c. 1880	1.5 story, front gabled ell plan, wood frame 4x4 bay residence. Entry in enclosed porch accessed by exterior stair. Vinyl and wood shingle siding, slate roof, replacement vinyl windows with aluminum storms.	N/A	Alterations include window replacements and front porch enclosure and vinyl siding. Retains integrity of setting, location, design, workmanship, feeling, association. Eligible as contributing resource to potential OEE HD.
BRIDGE							
9

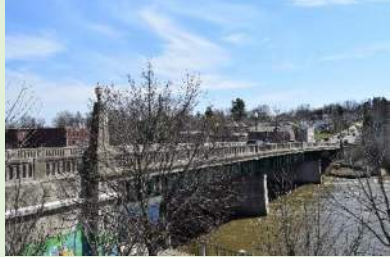
11-15	Bridge, Main St	1928	359' long, three-span, continuous steel riveted girder bridge with a cast in place concrete deck and cast in place ornamental concrete railings, sitting on concrete abutments. The concrete railings have repeating open arched windows. Cross bracing supports the four plate girders beneath the deck.	Winooski Falls HD #13	eligible for listing in the National Register under the Metal Truss, Masonry and Concrete Bridges of Vermont, 1820-1978 Multiple Documentation Property Form ("MPDF") as a Continuous Beam Span - Type 402 - Steel Continuous Girder.

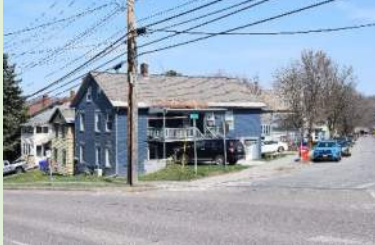
16, 17	6-8 Chase St	c. 1820	Greek Revival style 2.5 story, eaves front, 6x4 bay, masonry residence. Façade entry with simple Greek Revival surround, second story entry with multi-bay exterior porch. Stone foundation, and slate roof. Details include replacement windows, flat brick lintels, multilevel porch, and off-center brick chimney.	N/A	Alterations include window replacements and porch additions. Retains integrity of setting, location, materials, design, workmanship, feeling, association. Eligible as contributing resource to potential OEE HD.
11

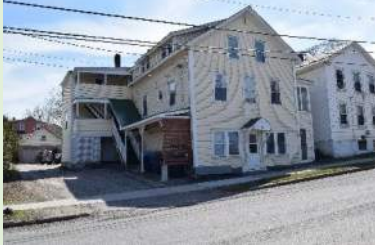
18	9 Chase St	c. 1865	2.5 story, eaves front, 3x5 bay, wood frame residence. Center bay façade entry, secondary entries towards rear and accessed by covered stair. Vinyl siding, replacement vinyl windows, shed roof dormers, and rear multilevel covered porch. Asphalt shingle roof.	N/A	Alterations include window and siding replacement. Retains integrity of setting, location, design, workmanship, feeling, association. Eligible as contributing resource to potential OEE HD..

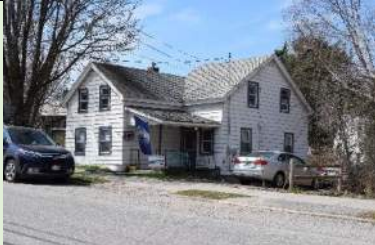
19	20 Chase St	c. 1850	1.5 story, front gabled ell plan, 4x4 bay, wood frame residence. Entry on ell sheltered beneath shed roof porch. Parged stone foundation, wide reveal vinyl siding, replacement windows, asphalt shingle roof, brick chimney.	N/A	Alterations include replacement siding and windows. Retains integrity of setting, location, design, workmanship, feeling, association. Eligible as contributing resource to potential OEE HD.

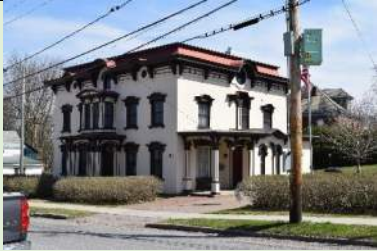
20	21 Chase St	c. 1870	High style Second Empire residence, 5x3 bay masonry residence. Center bay entry with ornate wood door sheltered by porch. Secondary entry beneath side porch. Original windows with drip mold, oriel windows near roofline, low mansard roof. Details include bay window, brackets under the eaves, columns and windows have ornate woodworking details.	N/A	No noticeable alterations. Retains integrity of setting, location, materials, design, workmanship, feeling, association. Eligible as contributing resource to potential OEE HD.
14

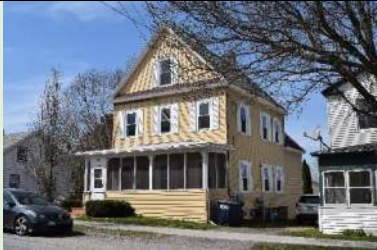
21	26 Chase St	c. 1910	2.5 story, 3x5 bay, front gabled, wood frame residence. Entry sheltered beneath enclosed screened porch with decorative posts. Stone foundation, replacement vinyl siding, and a slate roof. Details include closed pediment, replacement windows, and brick chimney.	N/A	Alterations include siding and window replacement. Retains integrity of setting, location, design, workmanship, feeling, association. Eligible as contributing resource to potential OEE HD.

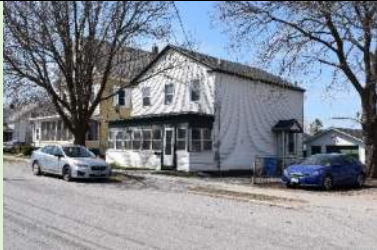
22	30 Chase St	c. 1870	2 story, 3x3 bay, front gabled wood frame residence. Entry sheltered beneath enclosed wooden porch; side entry sheltered by gabled porch. Stone foundation, replacement vinyl siding, replacement windows, asphalt shingle roof with end returns.	N/A	Alterations include siding and window replacement and enclosing the porch. Retains integrity of setting, location, design, workmanship, feeling, association. Eligible as contributing resource to potential OEE HD.

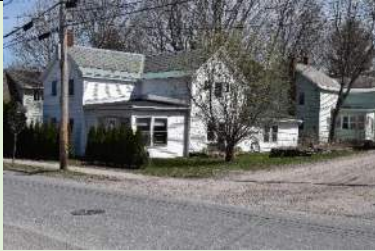
23	31 Chase St	c. 1870	1.5 story, 4x4 bay front gabled ell plan wood frame residence. Entry sheltered within enclosed wood porch within ell. Stone foundation, vinyl siding, patterned slate roof. Rear shed roof addition with standing seam metal roof. Replacement windows with aluminum storms, brick chimneys.	N/A	Alterations include siding and window replacement and the construction of enclosed porch and rear addition. Retains integrity of setting, location, design, workmanship, feeling, association. Eligible as contributing resource to potential Old East End OEE HD.
17

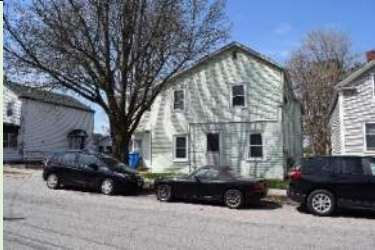
24	32-36 Chase St	c. 1850	2 story, 4x6 bay, front gabled masonry residence. Entries in center bay and far left bay. Original brick siding in right most façade bays, vinyl siding throughout the rest of the house, unevenly pitched asphalt shingle roof, enclosed porches on first and second stories. Replacement windows throughout.	N/A	Alterations include siding and window replacement and the construction of the enclosed porch addition. Retains integrity of setting, location, workmanship, feeling, association. Eligible as contributing resource to potential OEE HD.

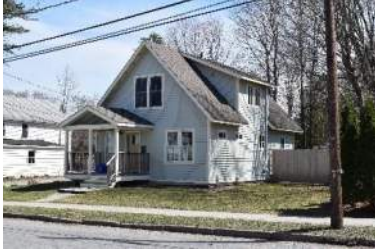
25	37 Chase St	2008	1.5 story, 3x3 bay, front gabled, wood frame residence. Entry off center on façade and sheltered beneath gabled porch. Concrete foundation, wood clapboard siding, asphalt shingle roof. vinyl windows and shed dormers on the side elevations.	N/A	Ineligible due to age

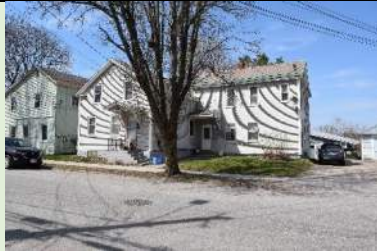
26	40 Chase St	c. 1870	1.5 story, 3x3 bay, wood frame, front gable block with substantial 2 story, 4x3 bay, rear ell. Façade and ell entries sheltered by ornate porches. Concrete foundation, vinyl siding, slate roof, replacement vinyl windows. Brick chimney and slight end returns on gable.	N/A	Alterations include siding and window replacement. Retains integrity of setting, location, design, workmanship, feeling, association. Eligible as contributing resource to potential OEE HD.
20

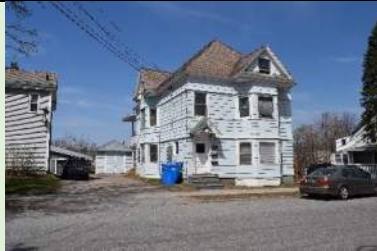
27, 29	46 Chase St	c. 1880	2.5 story, 4x6 bay, wood frame, hipped pyramidal roof residence. Entry on façade and sheltered by porch with ornate scrollwork. Concrete foundation, replacement vinyl siding, slate roof. Details include replacement vinyl windows, prominent multi story bay windows on the façade and side elevation, wall dormers, rear multistory porch, and brackets under the eaves.	N/A	Alterations include replacement siding and windows. Retains integrity of setting, location, design, workmanship, feeling, association. Eligible as contributing resource to potential OEE HD.

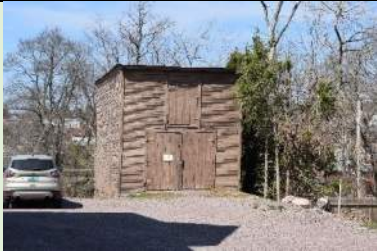
28	46 Chase St barn	c. 1880	<p>2-story, wood-frame, flat roof, carriage barn constructed into hill, which is very visible at the rear from Barrett St. The first story has double doors and the second story has a hayloft door. Small brackets are visible in the cornice. From Barrett St, the basement level is visible.</p> <p>This one is called out separately due to its visual prominence.</p>	N/A	<p>Unaltered outbuilding. Retains integrity of setting, location, design, materials, workmanship, feeling, association. Eligible as contributing resource to potential OEE HD..</p>
21

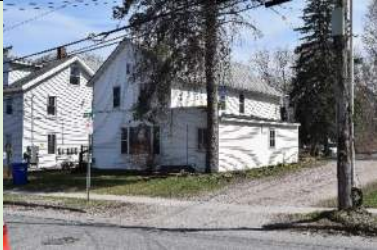
30	49 Chase St	c. 1900	<p>2.5 story, 3x5 bay, front gabled, wood frame residence with a one story shed roof addition. Entry in the addition. Stone foundation, vinyl siding, asphalt shingle roof. Replacement windows including prominent picture window.</p>	N/A	<p>Alterations include replacement siding, and windows. Retains integrity of setting, location, design, feeling, association. Eligible as contributing resource to potential OEE HD.</p>

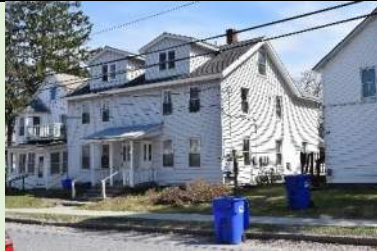
31	51-53 Chase St	c. 1880	2.5 story, 6x4 bay, eaves front gabled wood frame duplex with prominent flat roof rear addition. Center bay entries on façade sheltered by porch. Stone foundation, vinyl siding, asphalt shingle roof. Vinyl replacement windows and gabled façade dormers.	N/A	Alterations include replacement siding, windows, porch addition, dormers. Retains integrity of setting, location, design, workmanship, feeling, association. Eligible as contributing resource to potential OEE HD.
23

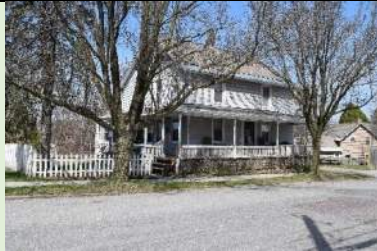
32	52-54 Chase St	c. 1870	2.5 story, 3x3 bay, eaves front gabled, wood frame residence. Entry set beneath porch that wraps multiple elevations. Concrete foundation, vinyl siding, slate roof. Prominent porch with turned posts, vinyl replacement windows, and brick chimney.	N/A	Alterations include replacement siding, windows. Retains integrity of setting, location, design, workmanship, feeling, association. Eligible as contributing resource to potential OEE HD.

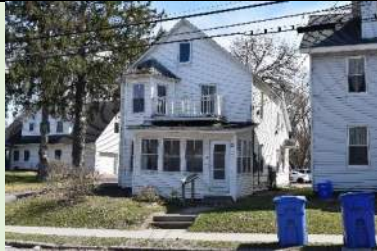
33	55 Chase St	c. 1900	2.5 story, 2x3 bay, front gabled wood frame residence. Entry set within enclosed shed roof façade porch. Side entry with gabled porch. Concrete foundation, vinyl siding, slate roof. Two story bay window, second story deck.	N/A	Alterations include replacement siding and windows. Retains integrity of setting, location, design, workmanship, feeling, association. Eligible as contributing resource to potential OEE HD.

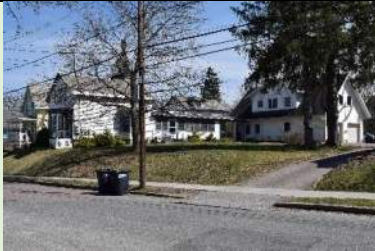
34	67 Chase St	c. 1870	Italianate, 1.5 story, 3x4 bay front gabled wood frame residence with significant rear additions. Entry set within an ornate Italianate style porch. Stone foundation, stone veneer and vinyl siding, slate roof with slight gable end returns. Bay window on side elevation.	N/A	Alterations include siding and window replacements, and a large rear addition. Retains features such as entry portico with brackets, return cornices, and side bay window. Retains integrity of setting, location, feeling, association. Eligible as contributing resource to potential OEE HD.
26

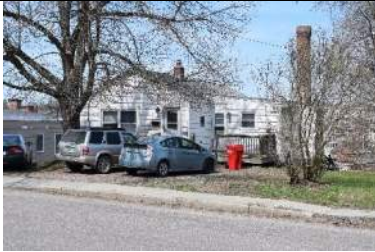
35	68 Chase St	c. 1950	1 story, wood-frame, front gabled, 5x3 bay residence with multibay shed roof addition. Façade entries in gabled mass and addition. Concrete foundation, wood siding, asphalt shingle roof. Details include wood deck, replacement windows, and a brick chimney.	N/A	Loss of integrity of materials, design, workmanship, feeling, association due to alterations. Ineligible.

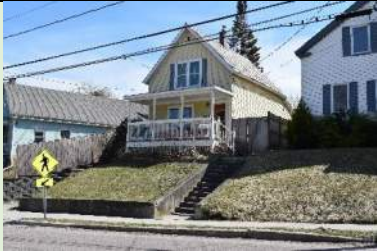
36	69 Chase St	c. 1890	1.5 story, 3x3 bay front gabled wood frame residence with shed roof rear addition. Entry set beneath full width hipped porch with turned posts. Building rises off a stone foundation, is clad in wood clapboard siding and topped by a slate roof. Vinyl replacement windows throughout, concrete block chimney.	N/A	Alterations includes siding and window replacements. Retains slate roof, full width front porch. Retains integrity of setting, location, design, workmanship, feeling, association. Eligible as contributing resource to potential OEE HD.
28

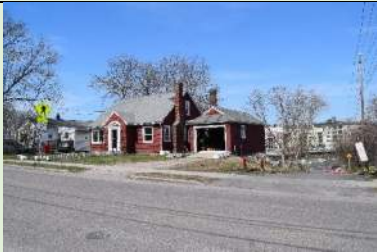
37	70 Chase St	c. 1950	Minimal Traditional, 1.5 story, 3x2 bay eaves front, wood frame residence with garage addition attached by breezeway. Entry in center bay via front gabled projection. Concrete foundation, clapboard siding, asphalt shingle roof. Large exterior brick chimney.	N/A	Alterations include window replacements and garage door replacement. Retains integrity of setting, location, materials, design, workmanship, feeling, association. Eligible as contributing resource to potential OEE HD.

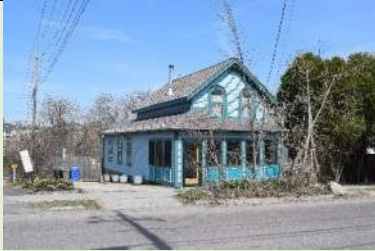
38	76 Chase St	c. 1880	Italianate, 1.5 story, 2x3 bay front gabled wood frame residence. Entrance in wrapping hipped roof porch. Stone foundation, wooden clapboard siding, slate roof on main building mass and asphalt shingle on enclosed porch. Mix of aluminum windows and original arched windows.	N/A	Alterations include porch enclosure and decorative panel additions to porch walls. Retains integrity of setting, location, design, materials, workmanship, feeling, association. Eligible as contributing resource to potential OEE HD.
29-1

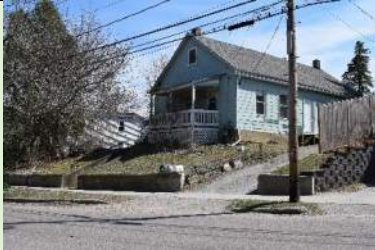
39	79 Chase St	c. 1900	1.5-story, wood-frame, 3x6 bay, gable front residence with ¾ width covered front porch on concrete foundation, overhanging eaves, asbestos siding, and vinyl windows. A separate, secondary 1.5 story, wood frame, gable roof house sits at the rear.	N/A	Alterations include additional side entrances, siding and window replacement. Retains integrity of setting, location, design, workmanship, feeling, association. Eligible as contributing resource to potential OEE HD.

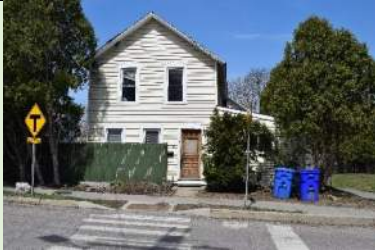
40	80 Chase St	c. 1870	2 story, 3x3 bay front gabled, wood frame residence with a significant 2x2 bay wood frame rear addition and a shed roof addition on the side elevation. Façade entry with wooden door. Vinyl siding, slate roof, vinyl replacement windows with prominent wood pediments.	N/A	Alterations include siding and window replacement and porch enclosure. Retains integrity of setting, location, design, feeling, association. Eligible as contributing resource to potential OEE HD.

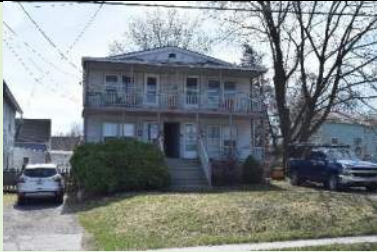
41	81-83 Chase St	c. 1930	2 story, 7x6 bay, front gabled, wood frame, multi-unit residence. Entries in center bays and accessed by elevated porch. Symmetrical façade. Stone foundation, vinyl siding, asphalt shingle roof. Double decker porch. with square posts vinyl windows with aluminum storms.	N/A	Alterations include replacement windows and siding. Retains integrity of setting, location, design, workmanship, feeling, association. Eligible as contributing resource to potential OEE HD.
32

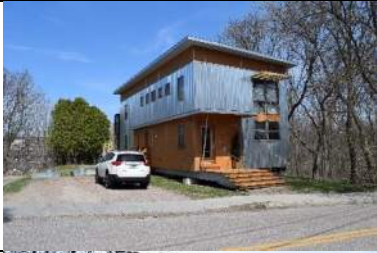
42	84 Chase St	2010	Modern energy efficient home. 2 story, 2x7 bays, flat roof, residence. Entry on façade. Building sits on concrete piers, composite and aluminum siding, metal windows.	N/A	Ineligible due to age
33

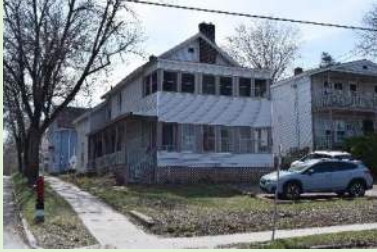
43	89 Chase St	c. 1875	2 story, 3x5 bay, front gabled, wood frame multi person residence. Entry sheltered by double decker enclosed porch. Concrete foundation, vinyl siding, slate roof. Wood windows and vinyl replacement windows. Brick chimney on façade.	N/A	Alterations include window and siding replacement and porch enclosure. Retains integrity of setting, location, design, workmanship, feeling, association. Eligible as contributing resource to potential OEE HD.

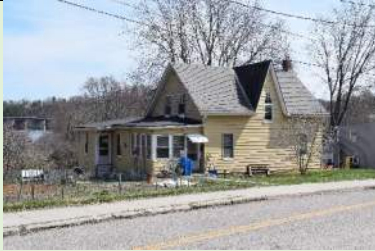
44	90 Chase St	c. 1875	1.5 story, 3x2 bay, eaves front, wood frame residence with 1 story addition on side elevation. Primary entry in 1 story addition. Concrete foundation, vinyl siding, asphalt shingle roof. Vinyl replacement windows with aluminum storms Prominent steeply pitched wall dormer. Brick chimney in gable end.	N/A	Alterations include window and siding replacement and porch enclosure/ construction of addition. Retains integrity of setting, location, design, workmanship, feeling, association. Eligible as contributing resource to potential OEE HD.
35

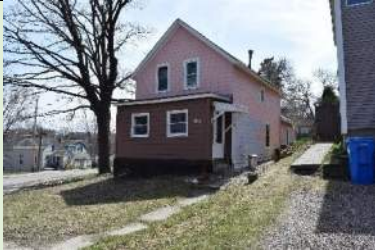
45	91 Chase St	c. 1890	1.5 story, 2x3 bay with a 1 story 2 bay addition off the rear elevation, front gabled, wood frame residence. Primary entry within 1 story enclosed porch on the façade. Concrete foundation, asbestos shingle siding, asphalt shingle roof. Vinyl replacement windows throughout.	N/A	Alterations include siding and window replacement and construction of enclosed porch. Retains integrity of setting, location, design, workmanship, feeling, association. Eligible as contributing resource to potential OEE HD.

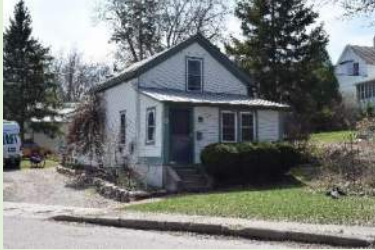
46	93 Chase St	c. 1880	1.5 story, 3x3 bay, front gabled, wood frame residence with 1 story 2 bay rear addition. Primary entry within 1 story enclosed, shed roof porch on the façade. Stone foundation, wood clapboard siding, slate roof. Vinyl replacement windows throughout.	N/A	Alterations include window replacement, generally intact. Retains integrity of setting, location, design, materials workmanship, feeling, association. Eligible as contributing resource to potential OEE HD.

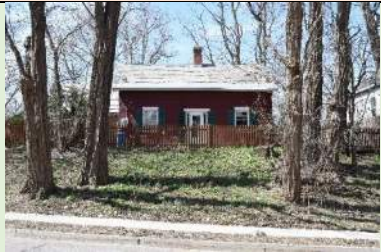
47,48	352 Colchester Ave	1820, 1970 addition	1.5 story, brick, 3x2 bay, gable roof, eaves front Classic Cottage with box cornice, splayed brick lintels, slate roof. The 1970 addition was designed by local architect Colin Lindberg and includes a slate roof, diagonal paneling glass walls.	SR 0402-352 Colchester Ave	Original building mass intact and unaltered. Large addition to the rear that is clearly delineated from original building. Retains integrity of setting, location, design, materials, workmanship, feeling, association. Eligible as contributing resource to potential OEE HD.
38

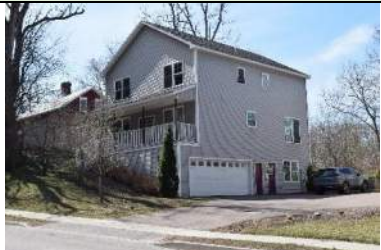
49	366 Colchester Ave	2012	2 story, 3x3 bay, wood frame, front gabled residence that sits on an elevated basement. Façade entry elevated and accessed by exterior stair. Entry sheltered by full width porch. Secondary entry in elevated basement; entry doors right of two bay garage. Concrete foundation, vinyl clapboard and vinyl shingle siding, asphalt shingle roof. Vinyl windows throughout.	N/A	Ineligible due to age

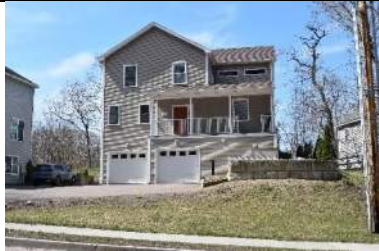
50	370 Colchester Ave	2016	2 story, 5x3 bay, wood frame, front gabled ell residence that sits on an elevated basement. Primary entry on façade via two roll up garage doors. Concrete foundation, vinyl clapboard and vinyl shingle siding, asphalt shingle roof. Vinyl windows throughout. First story shed roof porch with wood door and single sidelight.	N/A	Ineligible due to age
40

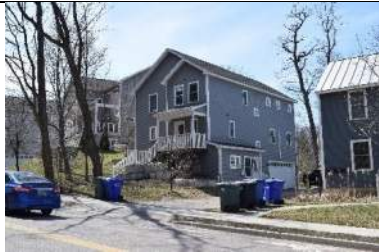
51	376 Colchester Ave	2016	2 story, 3x6 bay, wood frame front gabled ell residence that sits on an elevated basement. Primary entry elevated and accessed by exterior stair. Entry sheltered by one bay shed roof porch. Secondary entry in shed roof addition. Concrete foundation, vinyl siding, asphalt shingle roof. Vinyl windows throughout.	N/A	Ineligible due to age

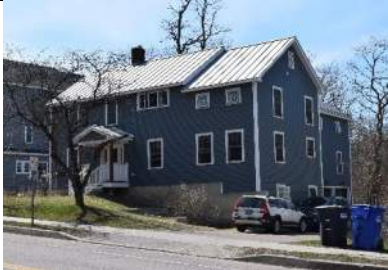
52	380 Colchester Ave	1938 (c. 2015 addition)	2 story, 5x2 bay, wood frame, eaves front gabled residence with a prominent 2 story rear addition. The building sits on an elevated concrete basement and has a center bay entry accessed by a gable roof porch. Vinyl siding and standing seam metal roof. Vinyl sash windows and vinyl hopper windows. Center bay brick chimney.	N/A	Alterations include removal of historic sidelights, window and siding replacement, and addition that is flush with the façade. Loss of integrity of materials, design, workmanship, feeling, association. Ineligible due to alterations.
42

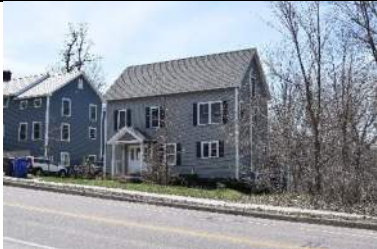
53	390 Colchester Ave	2016	2.5-story, wood-frame, 3x2 bay, eaves front, gable roof with gabled portico sheltering entrance on west side of front elevation.	N/A	Ineligible due to age
43

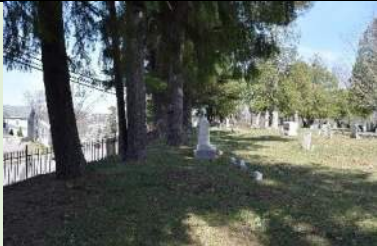
54	399 Colchester Ave	c. 1790	Green Mount Cemetery. C. 1790 burial ground that includes a mix of mature trees and headstones ranging from the 1790s to the early 2000s. Cemetery dominated by the Ethan Allen Monument.	N/A	Eligible as contributing resource to potential OEE HD.

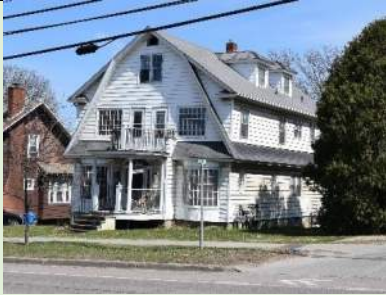
55	401 Colchester Ave	c. 1920	2.5 story, 3x5 bay, wood frame gambrel roof residence. Primary entry on façade sheltered by semi-circle porch with Doric columns. Entry details include sidelights and broad fanlight. Concrete foundation, vinyl siding, asphalt shingle roof. Prominent features include large bay windows, second story porch, shed roof and hipped dormers. Vinyl windows throughout.	N/A	Alterations include window and siding replacements. Retains integrity of setting, location, design, workmanship, feeling, association. Eligible as contributing resource to potential OEE HD.
45

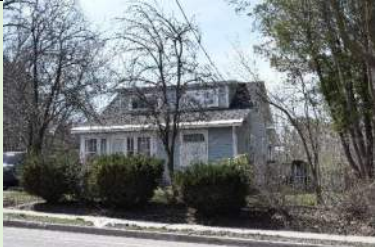
56	406 Colchester Ave	c. 1920	1.5 story, 3x2 bay, wood frame, eaves front gabled residence. Entry set in enclosed porch. Entry flanked by 4/1 and 6/1 wood windows. Wood clapboard siding, asphalt shingle roof, and multi-bay shed roof dormer.	N/A	Alterations include window replacement and removal of 1920s door. Retains integrity of setting, location, design, workmanship, feeling, association. Eligible as contributing resource to potential OEE HD.

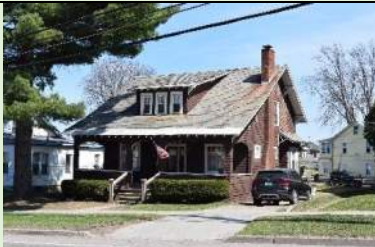
57	407 Colchester Ave	1924	1.5 story, 3x3 bay, wood frame, gable roof, eaves front, bungalow with full width recessed front porch, central 3-bay shed roof dormer, and exterior end chimney. Additional details include exposed rafter tails, shingle siding, half porch walls.	SR 0402 – 407 Colchester Ave	Retains integrity of setting, location, materials, design, workmanship, feeling, association. Eligible as contributing resource to potential OEE HD.

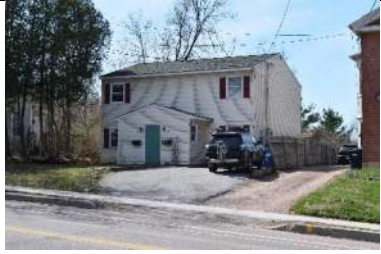
58	408 Colchester Ave	c. 1983	2 story, 5x3 bay, wood frame eaves front gabled roof residence. Primary entry set within 3 bay, gabled projecting vestibule. Concrete foundation, vinyl siding, asphalt shingle roof, vinyl windows with vinyl shutters.	N/A	Ineligible due to age.
48

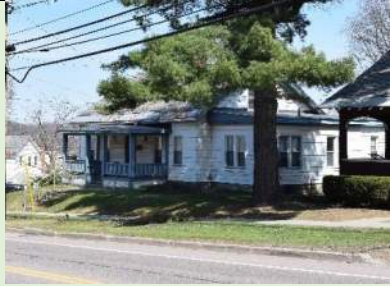
59,60	411 Colchester Ave	c. 1792	1.5 story, 3x5 bay, wood-frame, gable roof, eaves front with stone foundation and 1-story wing with 1-story, centered-covered front porch.	SR 411 Colchester Ave	Alterations include replacement siding and windows. Retains integrity of setting, location, design, workmanship, feeling, association. Eligible as contributing resource to potential OEE HD..
49

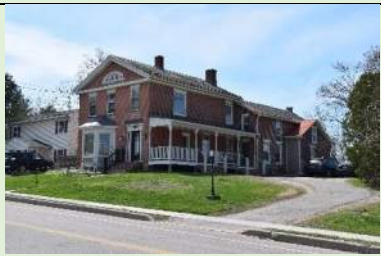
61	414 Colchester Ave	1832, ca. 1880 rear wing	2.5 story, brick, Greek Revival, 2x3 bay, pedimented gable front sidehall plan with 2-story rear wing and side elevation full width covered porch. Details include elliptical window in the gable, box cornice, front bay window, and splayed lintels.	SR 0402-414 Colchester Ave	Alterations include window replacements, porch railing replacements, but overall retains integrity of setting, location, design, materials, workmanship, feeling, association. Eligible under Criterion C – example of Greek Revival style. Eligible as contributing resource to potential OEE HD.

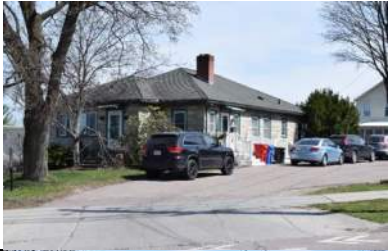
62	419 Colchester Ave	c. 1950	1 story, 3x5 bay, wood frame, hipped roof residence. Entries on Colchester Avenue façade and on Colchester Court. Stone veneer siding, asphalt shingle roof, and vinyl sash windows. Brick chimney.	N/A	Building retains all seven aspects of integrity. Building built outside of the Period of significance for the potential OEE HD.
51

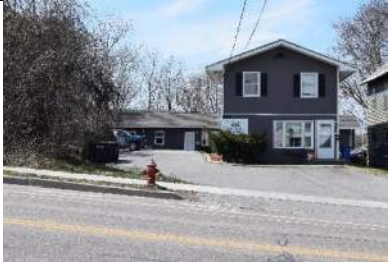
63	426 Colchester Ave	c. 1915 (rear), c. 1930 front building	2 story, 3x3 bay, wood frame front gabled residence with widely overhanging roof. 1 story T shaped addition attached to the rear of the front block. Façade entry, stucco siding, asphalt shingle roof. Vinyl windows including vinyl picture window.	N/A	Constructed as a machine shop at the rear of property with the front 2-story added. Loss of integrity of materials, design, workmanship, feeling, association. Ineligible due to alterations.

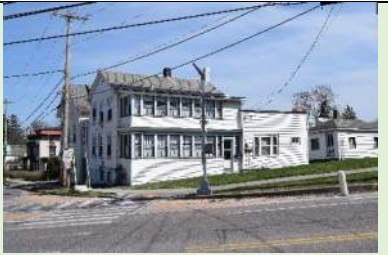
64	429 Colchester Ave	c. 1900	2 story, 3x5 bay, wood frame front gabled residence with a two-bay rear addition. Prominent two-story enclosed porch with primary entry and original 2/1 and 4/1 wood windows. Vinyl 1/1 windows on Chase Street elevation. Stone foundation, vinyl siding, slate roof with brick and concrete block chimneys.	N/A	Replacement siding and some replacement windows. Rear addition. Retains integrity of setting, location, design, workmanship, feeling, association. Eligible as contributing resource to potential OEE HD.

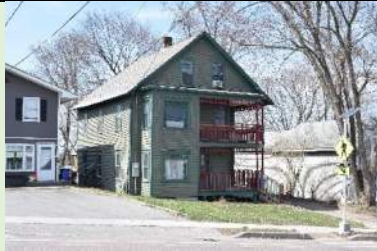
65	430 Colchester Ave	c. 1910	Craftsman style, 2.5 story, 3x3 bay, wood frame, front gabled residence with projecting bay window and two-story wrapping porch. Primary entry sheltered by porch. Stone foundation, wood clapboard siding, slate roof. Bay windows have colored glass panes, and there are also 1/1 wood windows.	N/A	Retains all seven aspects of integrity. Eligible as contributing resource to potential OEE HD.
54

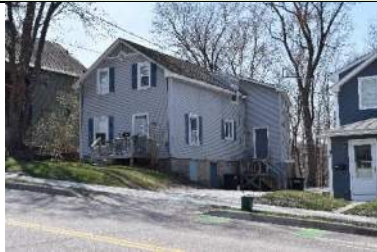
66	432-434 Colchester Ave	c. 1870	2 story, 2x3 bay, wood frame, front gabled residence with prominent rear addition. Entry on façade with small wood deck. Stone foundation, vinyl siding, asphalt shingle roof, vinyl windows with vinyl shutters.	N/A	Replacement siding, windows, major two-story addition off the rear of the building and shed roof dormer. Ineligible due to alterations.

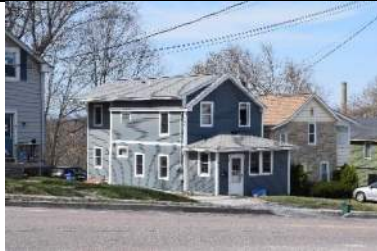
67	438 Colchester Ave	c. 1870	1.5 story, 2x3 bay, wood frame, front gabled residence. Full width enclosed hipped roof porch shelters entry. Building rises off concrete foundation, wood clapboard siding, asphalt shingle roof. Vinyl windows shed roof dormer.	N/A	Replacement windows, roof addition, and enclosed porch. Loss of integrity of design, materials, workmanship, feeling, association. Ineligible due to alterations.

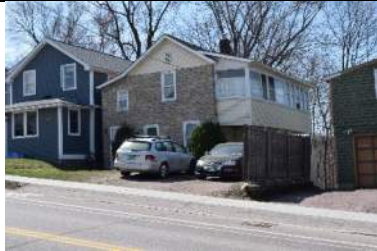
68	440-442 Colchester Ave	c. 1880	2 story, 3x3 bay, wood frame front gabled residence. Center bay entry and prominent second story enclosed porch on the side elevation. Stone veneer façade and vinyl siding. Asphalt shingle roof and brick chimney with vinyl replacement windows throughout.	N/A	Replacement windows, second story porch addition, altered siding. Loss of integrity of materials, design, workmanship, feeling, association. Ineligible due to alterations.
57

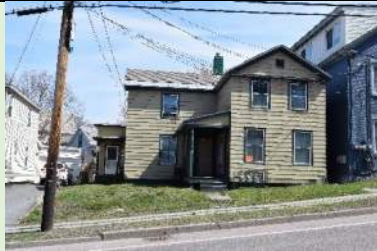
69	445 Colchester Ave	c. 1850	2 story, 4x4 bay, wood frame, front gabled ell residence. Multiple entries sheltered by shed roof porch with turned posts. Asbestos shingle siding, slate roof, wood 2/2 windows and brick chimney. Small rear addition projecting off ell.	N/A	Replacement siding, rear addition. Retains integrity of setting, location, design, workmanship, feeling, association. Eligible as contributing resource to potential OEE HD.

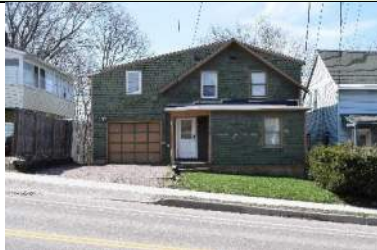
70	446 Colchester Ave	c. 1870	1.5 story, 3x5 bay, wood frame, front gabled residence with a prominent shed roof garage addition. Entry recessed in hipped roof vestibule. Concrete foundation, wood shingle siding, asphalt shingle roof.	N/A	Replacement siding, replacement windows, garage addition. Loss of integrity of materials, design, workmanship, feeling, association. Ineligible due to alterations.

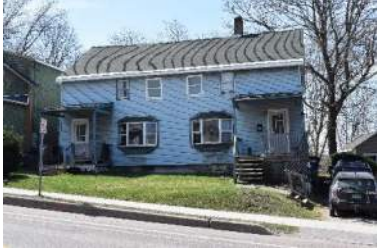
71	448-450 Colchester Ave	c. 1870	2 story, 4x2 bay, wood frame eaves front roofed duplex residence. Entries located on corner bays and accessed by shed roof porches. Concrete foundation, vinyl siding, asphalt shingle roof, vinyl windows and two prominent façade bay windows.	N/A	Alterations include altered fenestration and materials. Loss of integrity of materials, design, workmanship, feeling, association. Ineligible due to alterations
60

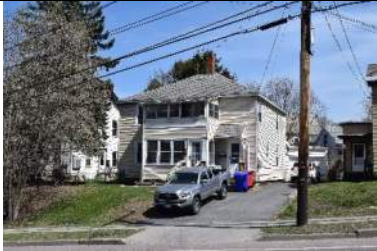
72	451 Colchester Ave	c. 1920	2 story, 4x4 bay wood frame hipped pyramid roof residence. Façade entry in 2 story enclosed porch second entry left of porch sheltered by shed roof porch. Concrete foundation, vinyl siding, and asphalt shingle roof. Replacement vinyl windows throughout and prominent brick chimney. Single car garage attached to the rear of the building.	N/A	Alterations include replacement windows and siding, enclosed porches, additional entrance. No character defining features remains except hipped pyramidal roof. Loss of integrity of materials, design, workmanship, feeling, association. Ineligible due to alterations.

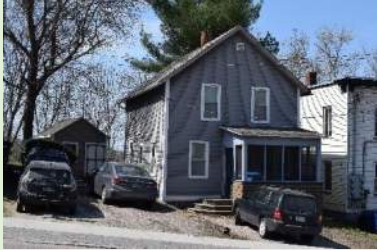
73	452 Colchester Ave	c. 1900	2 story, 3x3 bay, wood frame front gabled residence. Entry sheltered by shed roof screened porch. Stone foundation, vinyl siding, slate roof with mix of square and fish scale slates. Vinyl windows throughout and brick chimney.	N/A	Alterations include window and siding replacement. Retains slate roof, overhanging eaves. Retains integrity of setting, location, design, workmanship, feeling, association. Eligible as contributing resource to potential OEE HD.

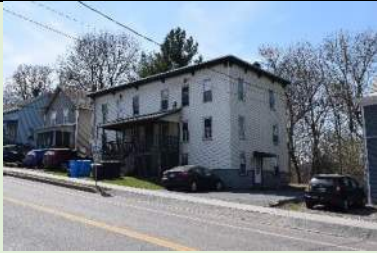
74	454 Colchester Ave	c. 1870	2 story, 7x3 bay, wood frame, flat roof residence that rises off an elevated basement. Elevated center bay façade entry sheltered by shed roof porch. Stone foundation, vinyl siding, membrane roof. Vinyl windows throughout and brackets beneath the eaves.	N/A	Alterations include window and siding replacements. Retains integrity of setting, location, design, workmanship, feeling, association. Eligible as contributing resource to potential OEE HD.
63

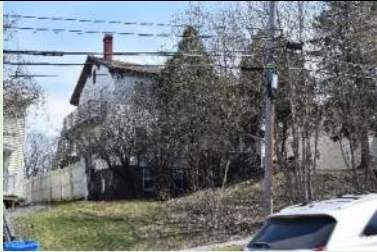
75	455-457-459 Colchester Ave	c. 1800	Italianate style, 2 story, 5x3 bay, wood frame eaves front gabled residence that rises off an elevated basement with a large rear wing that gives the building an overall T form. Entry sheltered by enclosed porch. Asbestos shingle and wide reveal vinyl siding, asphalt shingle roof. Vinyl windows throughout, paired brackets beneath the eaves, brick chimneys.	N/A	Hard to see through the vegetation, but appears to retain integrity of setting, location, design, materials, workmanship, feeling, association. Eligible as contributing resource to potential OEE HD.

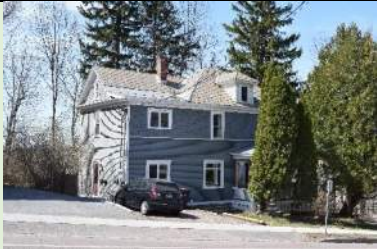
76	460 – 462 Colchester Ave	c. 1920	2.5 story, 3x3 bay, wood frame, hipped on gable roof residence. Primary entry on façade hipped roof porch. Concrete foundation, clapboard and wood shingle siding, slate roof. Mix of wood and aluminum windows. Closed pediment on side elevation, hipped dormer on façade and brick chimney. Enclosed two-story porch.	N/A	Alterations include enclosure of 2-story porch. Retains integrity of setting, location, design, workmanship, feeling, association. Eligible as contributing resource to potential OEE HD.
65

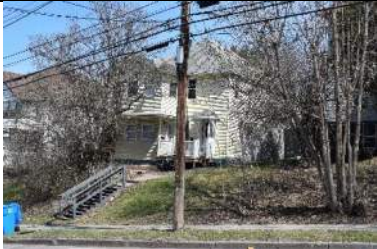
77	461-463-465 Colchester Ave	c. 1930	2 story, 4x4 bay, wood frame hipped pyramidal roof residence. Primary entries on façade. Concrete foundation, vinyl siding, asphalt shingle roof. Prominent 2 story, 2x1 bay front gabled addition on façade. Vinyl windows throughout and brick chimney at rear of building.	N/A	Alterations include replacement windows and siding and 2-story porch conversion to living space. Loss of integrity of materials, design, feeling, association. Ineligible due to alterations.

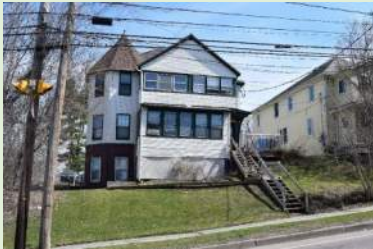
78	467 Colchester Ave	c. 1920	Queen Anne style 2 story, 3x5 bay, wood frame, hipped roof residence that sits on an elevated basement and uneven lot. Prominent two story enclosed gabled porch on façade. Primary entry set to the left of the porch and accessed by exterior stair. Stone foundation, vinyl siding, asphalt shingle roof. large hexagonal tower and shed roof dormers. Vinyl replacement windows throughout.	N/A	Alterations include replacement windows and siding and porch enclosure. Retains integrity of setting, location, design, workmanship, feeling, association. Eligible as contributing resource to potential OEE HD.
67

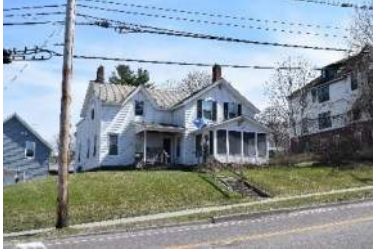
79	475 Colchester Ave	c. 1870	2 story, 4x4 bay front gabled ell wood frame residence. Entry set within ell and sheltered by shed roof porch. Brick foundation, wide reveal vinyl siding, slate roof. Prominent screened porch on façade, vinyl windows, and brick chimneys.	N/A	Alterations include front porch addition, windows and siding replacement.

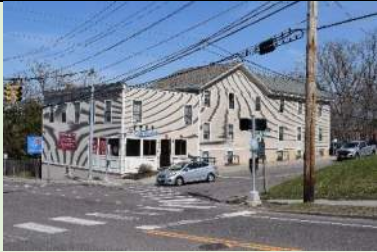
80	485 Colchester Ave	c. 1810	2 story, 3x5 bay wood frame flat roofed commercial building attached to 10 Barrett Street. Center bay primary entry, concrete foundation, vinyl siding, and membrane roof. vinyl and plate windows. Bracketed cornice.	Winooski Falls Mill HD #20	Since its 1993 listing, the front building has been changed (materials - siding, windows – and fenestration). The building has lost integrity of materials, design, workmanship, and feeling. It is recommended to remove this property from the Winooski Falls Mill Historic District.
EAST ALLEN ST							
69

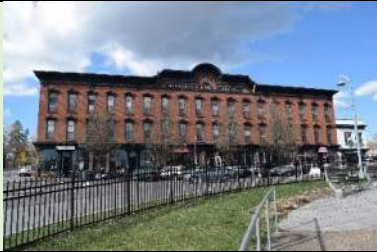
84	3 E Allen St	1867	Winooski Block. Large, 3-story brick building, 18 x 6 bays with ornamental details. Since the NR, the first story has been restored.	Individually listed NR "Winooski Block" (1974)	Remains eligible (listed).

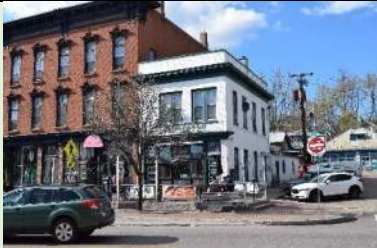
85	19 E Allen St	1867	McKees. Part of the Winooski Block. 2-story, brick commercial block, with storefront entrance, 4 bays deep, flat roof, projecting cornice below roofline	Mentioned as part of Winooski block NR	Remains eligible (listed).

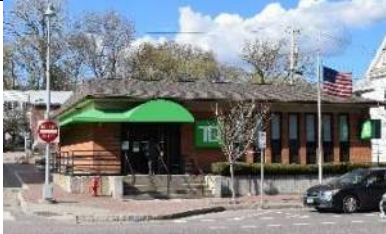
86	27 E Allen St	1973	TD Bank building. 1 story, 3x3 bay, masonry built hipped roof commercial building. Main entry composed of metal and glass doors accessed by concrete steps with metal rails. Concrete foundation, brick walls, asphalt shingle roof. Narrow single light aluminum windows.		Alterations include window replacement (loss of character defining feature). Does not rise to individual architectural significance and is not part of a HD. Ineligible due to alterations.
72

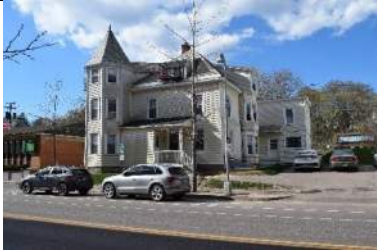
87	33 E Allen St	1905	Large Queen Anne style 2.5 story 3x6 bay wood frame, hipped pyramidal roof residence with multiple additions and alterations. Entry on façade. Concrete block and stone foundation vinyl siding, slate roof. Bay windows, hexagonal turret, brackets under the eaves, shed roof dormers. Vinyl replacement windows throughout and a brick chimney.	N/A	Alterations include windows, materials, fenestration replacement. No Queen Anne architectural details remain. Porch enclosed. Does not rise to individual architectural significance and is not part of a HD. Ineligible due to alterations.

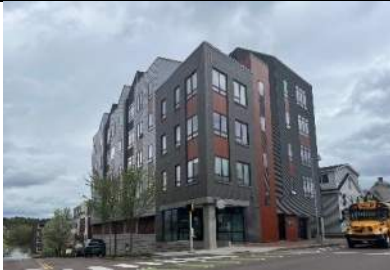
89	106 E Allen St	C. 2015	City Lights. Multiuse residential and commercial building, 4-5-stories above a parking garage with standard 2010s details including corrugated metal siding alternating with wood veneer and gray brick/stone veneer and slighting projecting/recessed bays. This building is topped by a sawtooth style roof. A recessed corner entrance is set at street level for retail businesses.	N/A	Ineligible due to age.
