Burlington-Winooski BF RAIZ(2)

Bridge No. 150

On behalf of the Vermont Agency of Transportation (“VTrans”), VHB has prepared this Historic Resources Identification Report (“report”) as part of the regulatory planning process for Burlington-Winooski BF RAIZ(2) (“Project”). This report documents resources protected under Section 106 of the National Historic Preservation Act (“Section 106” and “NHPA”), (36 CFR 800 / 16 U.S.C. 470) and Section 4(f) of the Department of Transportation Act (“Section 4(f)”), 23 C.F.R. 774 / 49 U.S. 303.

The Project proposes to remove and replace the Winooski Bridge (Bridge No. 150), which carries US Route 2 / US Route 7 over the Winooski River between Burlington and Winooski, VT. Also called the “Main Street Bridge”, this is the only crossing over the Winooski River that connects the cities. The new bridge is proposed for the same alignment, but wider. The current bridge has narrow travel lanes, no shoulders, and narrow sidewalks. For this reason, potential indirect impacts of this changed on adjacent resources must be considered, as well as the impacts during construction.

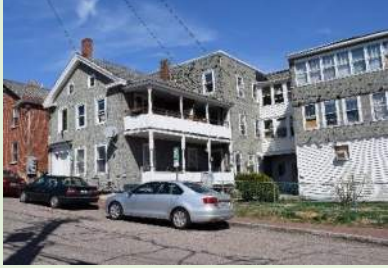
90, 91	27-29 Follett St (Physically connected to 7-9-11 W. Canal Street, Map ID #110).	c. 1850	Greek Revival style 2.5 story, 3x3 bay wood frame front gabled residence. Entry on façade has Greek Revival surround. Concrete foundation, asphalt shingle siding, and slate roof. Details include a prominent 2 story porch on side elevation, replacement vinyl windows throughout, and brick chimneys at roof peak, and return cornices. This is the residential section of the historically connected buildings.	0418-43	Alterations include siding and window replacement. Retains entrance entablature, cornice returns. Rear additions and connected to adjacent buildings. Eligible as a contributing resource in potential Winooski Falls Historic District ("WFHD") under Criterion C as an example of mixed use commercial and worker housing in Winooski Village.

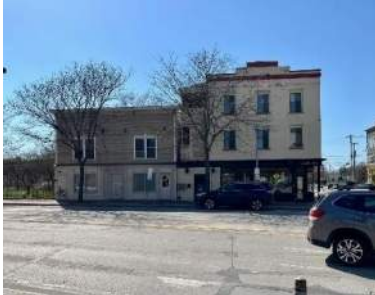
94	8 Main St (at left)		2-story, wood-frame, 4x4 bay, Italianate commercial block with recessed entrance, paneled design on first-story, single pane vertical replacement windows throughout, cornice brackets.	Winooski Falls Mill HD (#4) – N/C	Alterations to siding, window fenestration, materials. Loss of integrity of setting, materials, design, workmanship, feeling, association. Ineligible due to alterations.
78

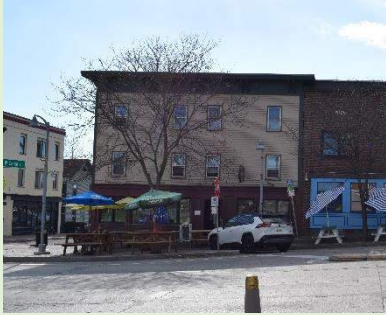
96	24-26 Main St	1884	3 story, Italianate, 4x7 bay, wood frame, flat roof commercial building. Multiple commercial storefront entries on façade and West Canal Street entry. Concrete foundation, wood clapboard siding, membrane roof. Vinyl replacement windows throughout and paired brackets beneath roof eaves. Grazers Winooski	SR 0418-1	Retains integrity of location, design, materials, workmanship, feeling, association. Eligible as a contributing resource in a potential WFHD under Criterion C as a mixed use commercial building.
80

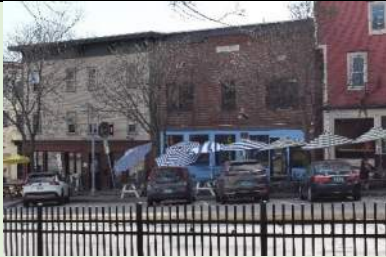
97	26 Main St	1938	2 story, 3x4 bay, masonry, flat roofed commercial building. Wood and glass commercial storefront entry. Concrete foundation, brick walls, membrane roof. Aluminum windows and decorative brickwork near roofline. Sneakers Bistro	SR 0418-2	Alterations include window openings and storefront openings. Loss of integrity of design, setting, workmanship. Eligible as a contributing resource in a potential WFHD under Criterion C as a mixed-use commercial building.

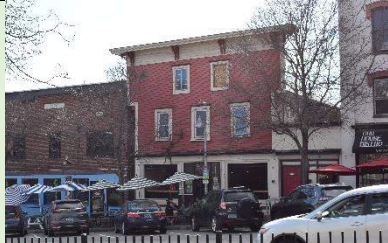
98	30 Main St	1880	3 story, 3x8 bay wood frame gabled commercial building with a false front parapet. Wood and glass commercial storefront entry. Concrete foundation, wood clapboard siding, asphalt shingle roof. Vinyl replacement windows and bracketed cornice. Right of the building there is a one story wood frame addition with two wooden doors. Monkey House.	SR 0418-3	Alterations include window replacements. Retains integrity of location, design, workmanship, feeling, association. Eligible as a contributing resource in a potential WFHD under Criterion C as an Italianate mixed-use commercial building.
82

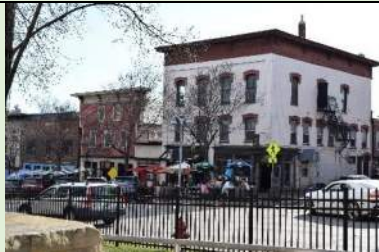
99	36-38 Main St	1880	Italianate style 3 story, 4x5 bay, flat roofed, masonry commercial building. Two storefront entries with large wood and glass storefront systems with plate glass windows. Brick foundation, brick walls, membrane roof. Details include original 2/2 windows with drip molding, and paired brackets at the cornice line. Our House Bistro & Mule Bar	SR 0418-4	Retains character defining features. Retains integrity of location, materials, design, workmanship, feeling, association. Eligible as a contributing resource in a potential WFHD under Criterion C as an Italianate mixed-use commercial building.

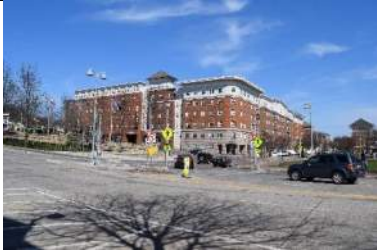
100	41-45 Main St	2005	6 story, U shaped housing complex which wraps much of Main Street, Winooski Falls Way, and Cascade Way. Skeletal steel frame building with brick veneer walls, false stone, and vinyl siding. Flat membrane roof and vinyl windows. Spinner Place	N/A	Ineligible due to age
84

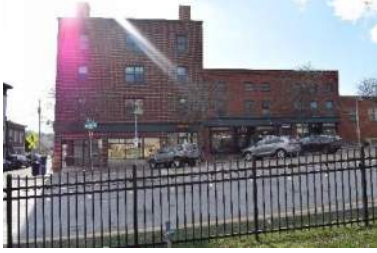
101	46 Main St (building at left)	1980s	4 story, 3x8 bay flat roofed, masonry commercial building. Recessed metal and glass commercial storefront entry. Concrete foundation, brick walls, and membrane roof. Aluminum windows throughout, bays divided by brick piers. Optum & Misery Loves Company	Replaced 0418-5 (burned early 1980s), left	Ineligible due to age
85

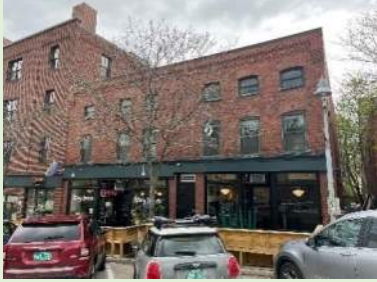
102	46 Main St (Misery Loves Company building)	c. 1875, ca. 1910 facade	3-story, 6x1 bay, brick, commercial block with brick cornice, arched windows and lintels, and storefronts with recessed entrances flanking central single door entrance to upper stories.	SR 0418-6	Alterations include second story window replacement. Retains integrity of location, design, materials, workmanship, feeling, association. Eligible as a contributing resource in a potential WFHD under Criterion C as an early 20 th century mixed-use commercial building.

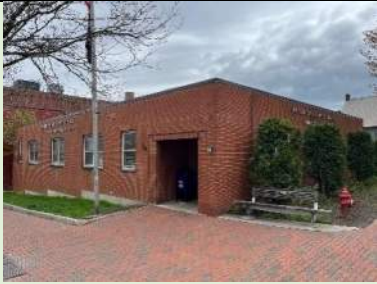
103	50 Main St	1961	1 story on a sloping site, 6x3 bay, flat roofed masonry governmental building. Recessed entry, concrete foundation, brick walls, membrane roof. Aluminum storm windows. USPS.	N/A	Eligible under Criterion C as an example of a 1960s (Thousand Series Modern Style) USPS office in Vermont. Eligible in potential WFHD as a midcentury example of a government building.
87

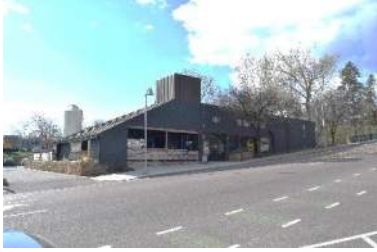
105	70 Main St	Ca. 1950	1 story, 4x6 bay flat roofed masonry commercial building. Center bay entry with glass and metal storefront. Concrete foundation, brick walls, membrane roof. Prominent standing seam metal shed roof addition which creates enclosed porch space. Four Quarters. Constructed as a Grand Union and then used as a Key Bank.	N/A	Building has been altered in design and materials in its various forms. Loss of integrity of design, materials, workmanship, feeling, association. Ineligible due to alterations

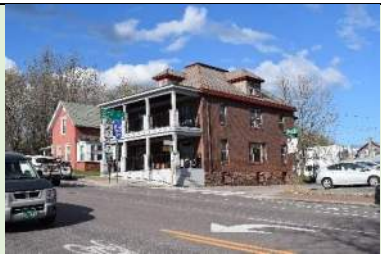
106	71 Main St	Ca. 1915	Four Square 2.5 story, 3x3 bay hipped roof residence. Center bay entry sheltered by 2 story porch with wood shingle siding. Stone foundation, brick walls, and slate roof. Details include split brick lintels, hipped dormers, and replacement vinyl windows.	N/A	Retains integrity of setting, location, materials, design, workmanship, feeling, association. Eligible under Criterion C as an intact example of a Four Square.
90

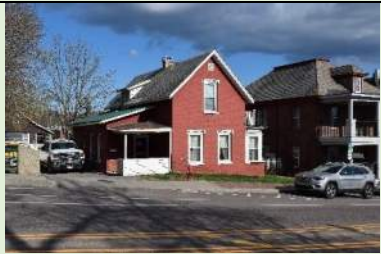
107	75 Main St	1865	Italianate, Gothic Revival 1.5 story, 2x3 bay, front gabled, masonry residence. Small shed roof addition and prominent rectangular bay window. entry sheltered by small porch. Stone foundation, brick walls, slate roof. Vinyl replacement windows with brick lintels. Shed roof dormer and brick chimney.	SR 0410-8	Retains integrity of setting, location, materials, design, workmanship, feeling, association. Eligible under Criterion C as an intact example of Italianate/Gothic Revival

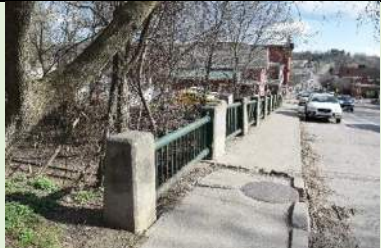
108	Main Street / NECR bridge	1952	Concrete slab bridge carrying road over NECR tracks, with railing consisting of intermittent concrete posts and steel pipe railing with balusters and stepped concrete endwalls.	N/A	Eligible under Historic Bridges MPDF as an example of a rare survivor of a once common type with intact railing.

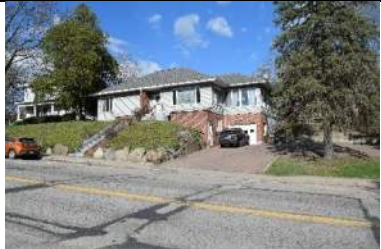
109	101 Main St	1953	1-story, asymmetrical 3x3 bay, residence, recessed front entry, with above-grade basement/garage at street level. Hipped roof with L(?) style floor plan.	N/A	Alterations to windows and siding. Loss of integrity of materials, design, workmanship. Does not rise to level of individual significance.
93

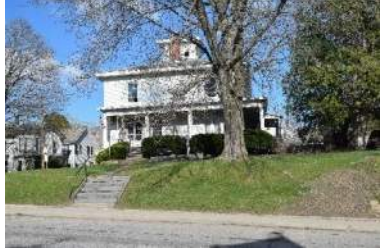
110	109 Main St	1818	2-story, hipped roof, square plan, residence, cupola at peak of roof, 3x4 bays, wraparound porch, paired brackets on porch, double doors entrance, raised basement, chimney on front slope of roof. Vinyl siding and replacement windows. Altered fenestration on front facades (windows removed, door relocated). Relocated chimney. Federal style building with Italianate elements.	SR 0418-7	Alterations to windows, fenestration, and siding. Loss of integrity of, materials, design, workmanship, feeling and association. Ineligible due to alterations.

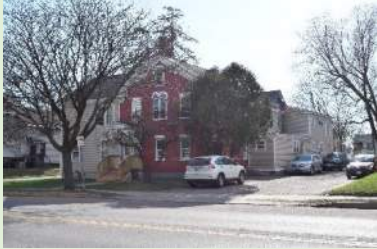
111	114 Main St	1857	2.5 story Italianate residence (apartments), brick main block with paired brackets, molded cornice with frieze, end returns, flat arches, paired rounded windows in central bay, side hall entrance with double doors, pedimented entrance porch, decorative chimney. South (side) wing addition flush with facade. Long rear ell and shed.	SR 0418-9	Retains integrity of setting, location, materials, workmanship, feeling, association. Eligible within a potential Main Street Historic District. Relatively intact Greek Revival/Italianate
95

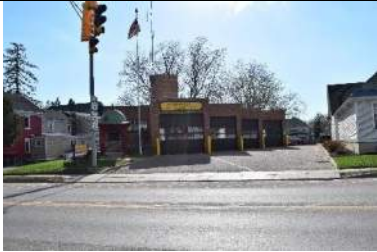
112	120 Main St	1977	Fire department. 1-story, angular, brick building with tower section rising from the south end. The north of the building contains four engine bays stepped back one by one from the front façade.	N/A	Ineligible due to age

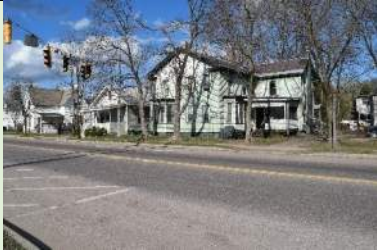
113	121 Main St	1890	2.5 story gable front residence, L-plan with entrance in the ell. The main block faces the street and has projecting 1-story bay windows on the west and south elevations. Slate roof, vinyl siding, replacement windows, parged stone foundation.	N/A	Alterations include window and siding replacement. Retains integrity of location, setting, design, workmanship, feeling and association. Eligible within a potential Main Street Historic District.

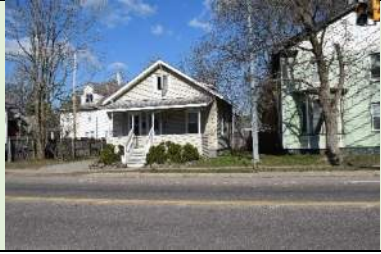
114	125 Main St		1.5 story, gable front, 3x3 bay residence on a concrete foundation. Full width front porch with shed roof, half wall and turned balusters. Vinyl siding, replacement windows.	N/A	Retains integrity of setting, location, design, workmanship, feeling, association. Eligible within a potential Main Street Historic District.
MAPLE STREET							
98

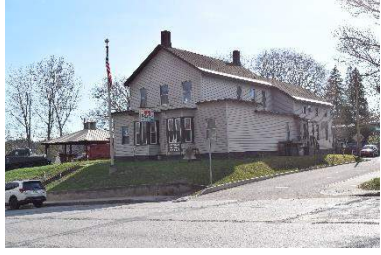
154	6 Maple St.	1860	VFW. 2.5 story, gable roof building with projecting bay windows on first story front façade, rear wing addition and 1 story side additions. Vinyl siding and windows, original entry obscured. Original massing obscured due to alterations.	N/A	Alterations include windows and siding replacements, enclosed porches, addition. Loss of integrity of materials, design, workmanship, feeling. Ineligible due to alterations.

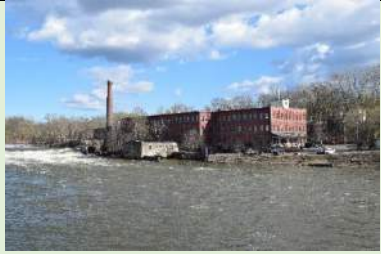
117, 118	1 Mill St	1892	3 story, 9x35 bay, masonry and heavy timber frame, flat roof industrial building that has been converted to business space. Multiple entries. Stone foundation, brick walls, membrane roof. Wood 12/8 windows with arched brick lintels. Large exterior smokestack and ruins of powerhouse. Chace Cotton Mill.	Winooski Falls Mill HD #1	Remains eligible (listed).

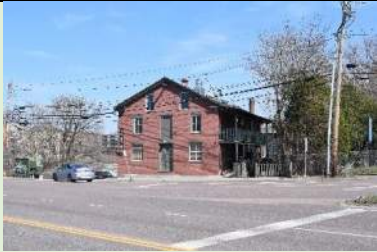
119,120	3 Mill St (497 Colchester Ave)	1850	2.5 story, 3x5 bays, brick veneered, shallow gable roof that sits on an elevated basement. Mixed commercial and residential property. Mix of 8/8 and 2/2 windows with flat stone lintels, stone foundation, slate roof.	Winooski Falls Mill HD #15 / SR 497 Colchester Ave	Since the SR and NR, the building has been raised and the ground level has become the upper story, but the first floor became below grade when the bridge was constructed. Retains integrity of setting, location, materials, design, workmanship, feeling, association. Remains eligible (listed).
101

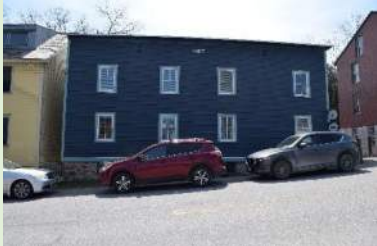
121	7-9 Mill St	1853, 1874	2-story, wood-frame, 4x2 bay, former tenement building with flat roof, clapboard with simple bracketed cornice.	Winooski Falls Mill HD #16	Remains eligible (listed).

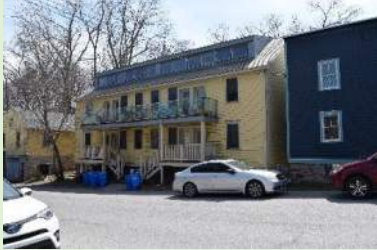
122	17-19 Mill St	1853	2.5 story, 10x2-bay, wood-frame, gable roof, eaves front former tenement building with 2-story porch centered on façade and shed roof dormer with awning windows. Clad in wood siding with replacement windows.	Winooski Falls Mill HD #16	Remains eligible (listed).

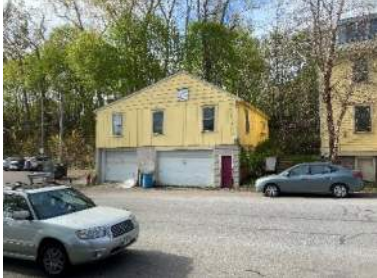
123	21 Mill St	1972	2-story structure with concrete foundation and T1-11 clad second story. 1/1 windows, metal roll up garage doors, unevenly pitched front gable asphalt shingle roof.	Winooski Falls Mill HD #17a	N/C in HD. Remains ineligible as it outside the period of significance for the HD.
104

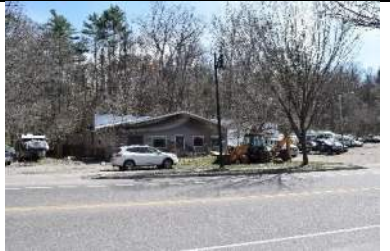
129	114 Riverside Ave	c. 1970	1 story 5x3 bay, wood frame, front gabled commercial building with a large 1 story 7x4 bay masonry garage addition to the rear. Center bay entry, fixed pane windows. Vinyl siding, asphalt shingle roof. Rear addition, brick walls and membrane roof.	N/A	Alterations include siding and window replacements, overhead door replacements. Loss of integrity of materials, design, workmanship, feeling, association. Ineligible due to alterations.

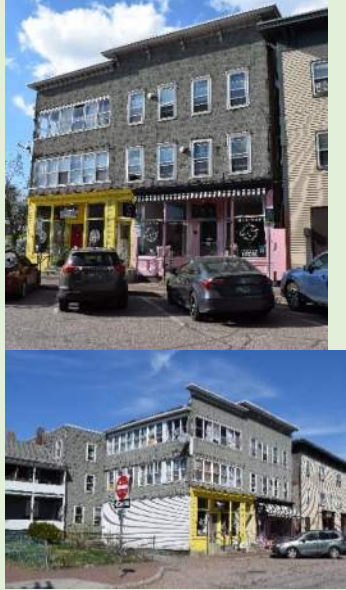
131	7-9-11 W Canal St Physically connected to 27-29 Follett St (Map ID 74)	c. 1883	Connected commercial buildings, both 3 stories with 4 upper bays across the façade, and prominent wood and glass commercial storefront with center bay entry. Buildings sit on a stone foundation with asphalt shingle siding and membrane roof. Replacement 1/1 vinyl windows throughout and bracketed cornice. Historically connected to 27-29 Follett Street. This is the commercial portion of the connected property.	0418-42	Alterations include siding and window replacements but retains historic storefront and cornice details. Retains integrity of setting, location, design, workmanship, feeling, association. Eligible under Criterion C as an example of a downtown Italianate commercial block with significant residential additions off its rear elevation.

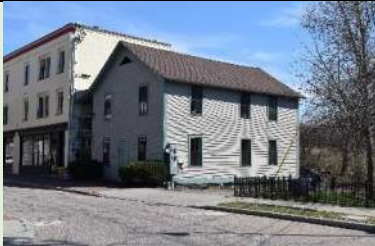
133	12 W Canal St	c. 1855	2 story, 3x5 bay, wood frame, front gabled residence. Center bay entry. Stone foundation, wood clapboard siding, asphalt shingle roof. 2/2 windows and two-story side porch.	Winooski Falls Mill HD #6	Remains eligible (listed).
113

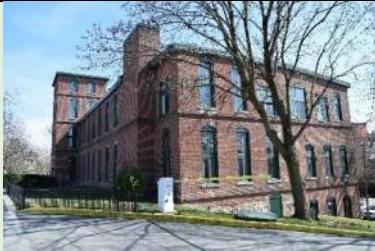
134,135	20 W Canal St		Large former textile mill. Stone foundation, brick walls, and flat roof. Metal and glass windows many of which have arched brick lintels and stone sills. Brick detailing is also present in many parts of the mill. Woolen Mill apartment complex.	Winooski Falls Mill HD #7	Remains eligible (listed).

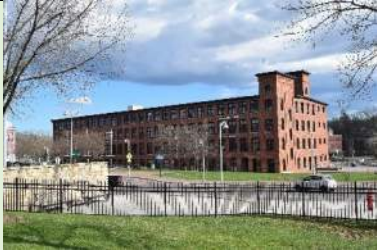
137,138	20 Winooski Falls Way	1912	4 story, 8x28 bay, masonry and heavy timber frame widely pitched gabled roofed textile mill. Large regularly spaced windows with broad brick arches and stone sills. Concrete foundation, brick walls, and membrane roof. Large addition on rear elevation. Champlain Mill.	Winooski Falls Mill HD #2	Remains eligible (listed).
115

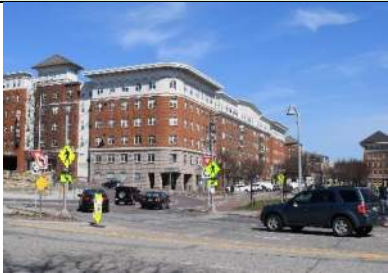
139	25 Winooski Falls Way	2005	6 story, U shaped housing complex which wraps much of Main Street, Winooski Falls Way, and Cascade Way. Skeletal steel frame building with brick veneer walls, false stone, and vinyl siding. Flat membrane roof and vinyl windows. Spinner Place.	N/A	Ineligible due to age
116

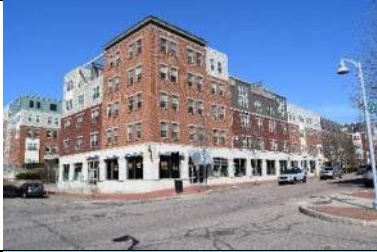
141	65 Winooski Falls Way	c. 2005	Large L shaped 4-5 story mixed commercial and residential building. Concrete foundation, brick veneer, vinyl and metal siding. Concrete lintels, vinyl and metal windows. Keen's Crossing.	N/A	Ineligible due to age
118

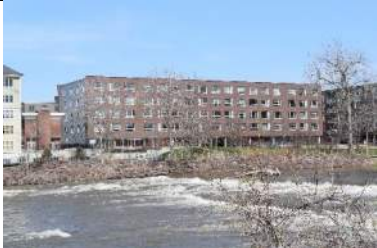
142	80 Winooski Falls Way	c. 2005	5 story, 17x4 bay, steel frame, flat roof apartment complex. Building rises off concrete pillars is clad in vinyl and brick veneer and topped by membrane roof. metal windows.	N/A	Ineligible due to age
119

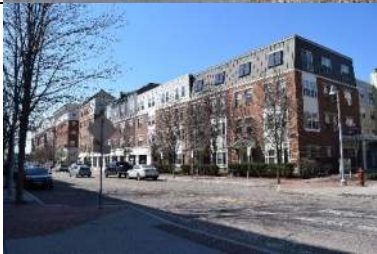
143	85 Winooski Falls Way	c. 2005	4 story 4x3 bay, wood frame, mansard roof apartment complex. Multiple entryways sheltered by shed roof porches. Concrete foundation, brick veneer siding, and metal roof. Bay windows, 1/1 windows with concrete lintels.	N/A	Ineligible due to age
120

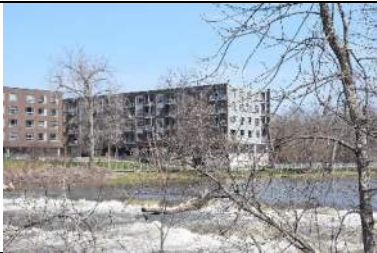
144	110 Winooski Falls Way	c. 2005	4 story, 14x5 bay, steel frame flat roof apartment complex. Building rises off concrete pillars is clad in vinyl and brick veneer and topped by membrane roof. metal windows.	N/A	Ineligible due to age

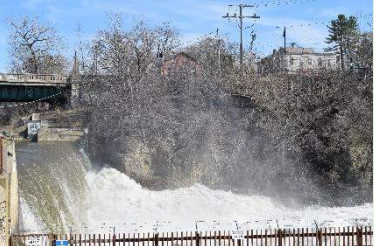
152		c. 1823, 1854, 1927	Burlington Flouing Company Grist Mill Site, located adjacent to the lower crib dam near the SW corner of the Winooski Bridge. The site includes portions of the mill's brick foundation walls, floodgates, and sluiceway are the district's only remaining references to the industries on the Burlington side of the Winooski River's lower falls.	Winooski Falls Mill HD #14	Remains eligible (listed).

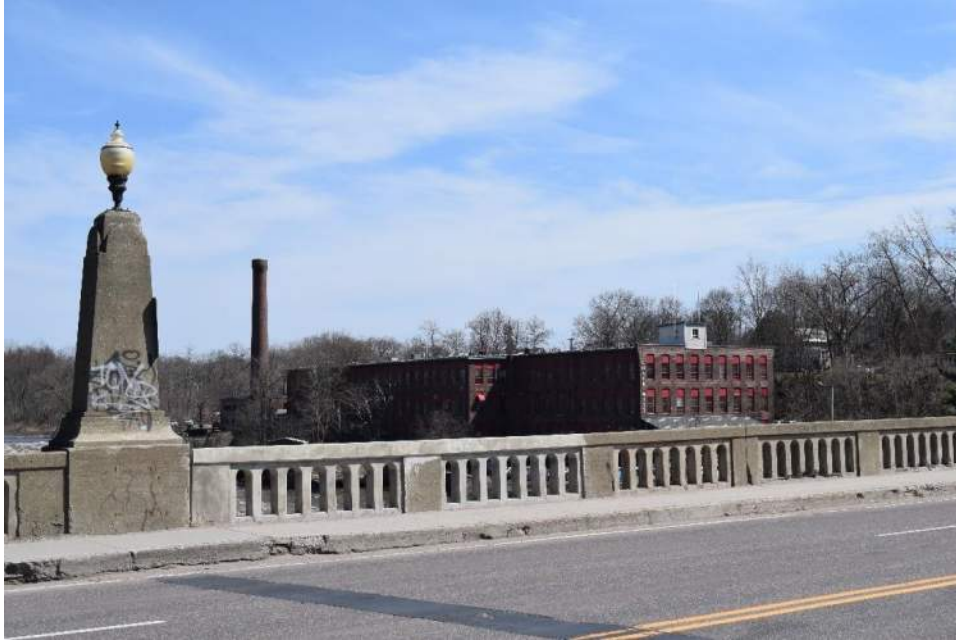
Photo 13: Bridge railing and ornamental details. Chace Mill in the background. Map ID 9.

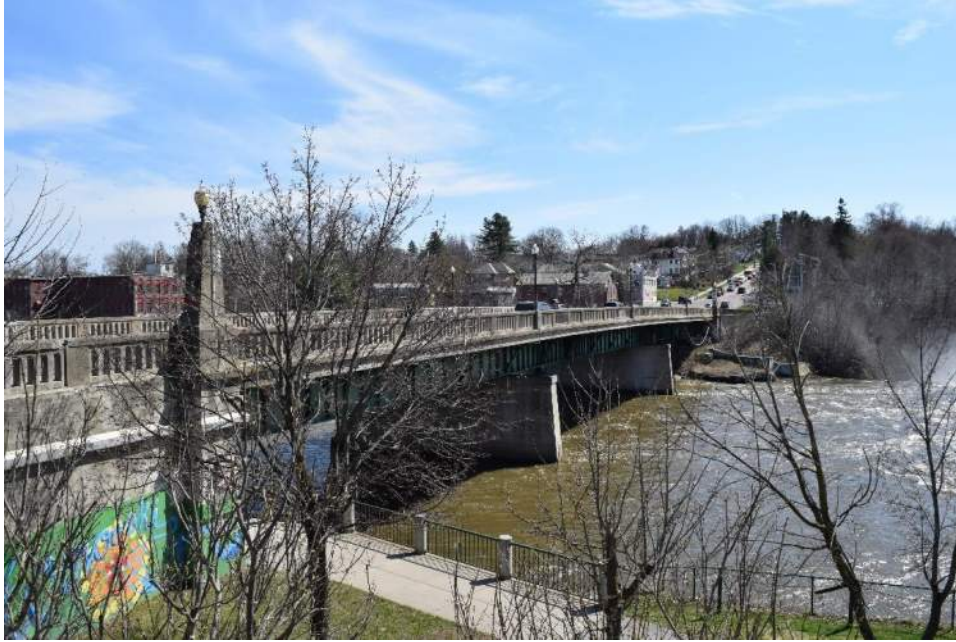
Photo 15: Bridge showing the decking and piers. Map ID 9.

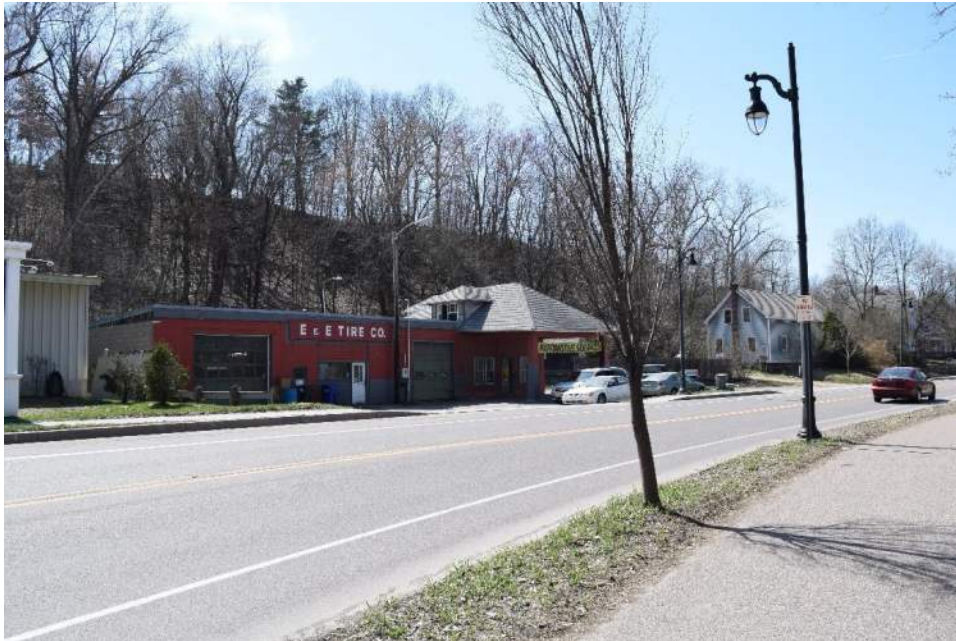
Photo 127: 152 Riverside Avenue. Map ID 106.

127	152 Riverside Ave	c. 1925	1.5 story, 2x3 bay, wood frame, hipped pyramidal roof automobile shop with a 1 story, 3x2 bay shed roof garage addition. Façade entry sheltered by roof overhang. Concrete foundation concrete block and clapboard siding, asphalt shingle roof. Hipped dormers.	152 Riverside Ave, Burlington (SR)	Retains integrity of setting, location, materials, design, workmanship, feeling, association. Eligible under Criterion C as example of a 1920s service station in Burlington.
107

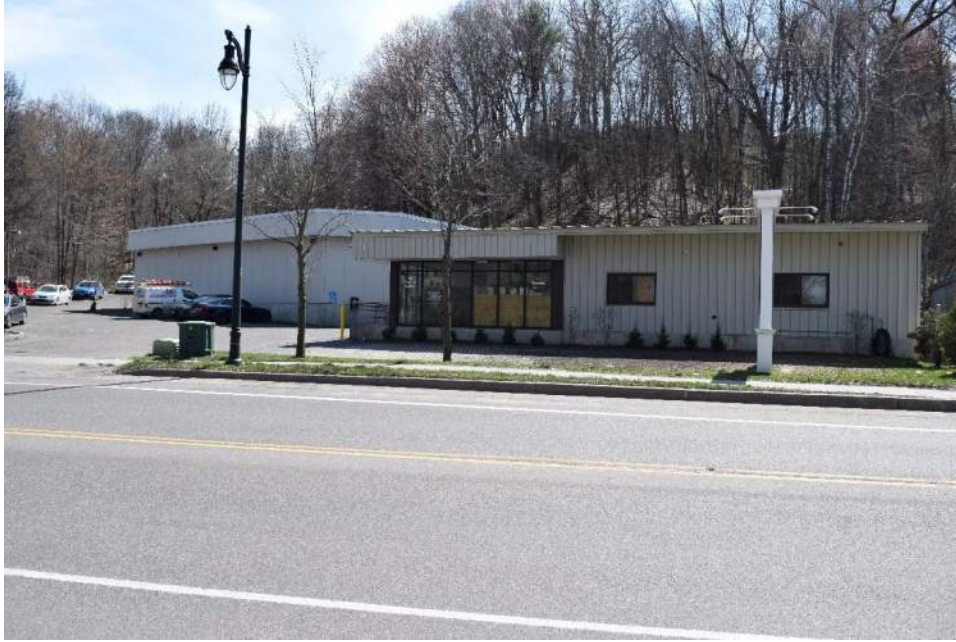
Photo 128: 140 Riverside Avenue. Map ID 107.

128	140 Riverside Ave	c. 1990	1 story, 3x4 bay, wood frame eaves front gabled, commercial building. Metal and glass commercial storefront accessed by concrete ramp. Concrete foundation, metal siding, and standing seam metal roof.	N/A	Ineligible due to age
108

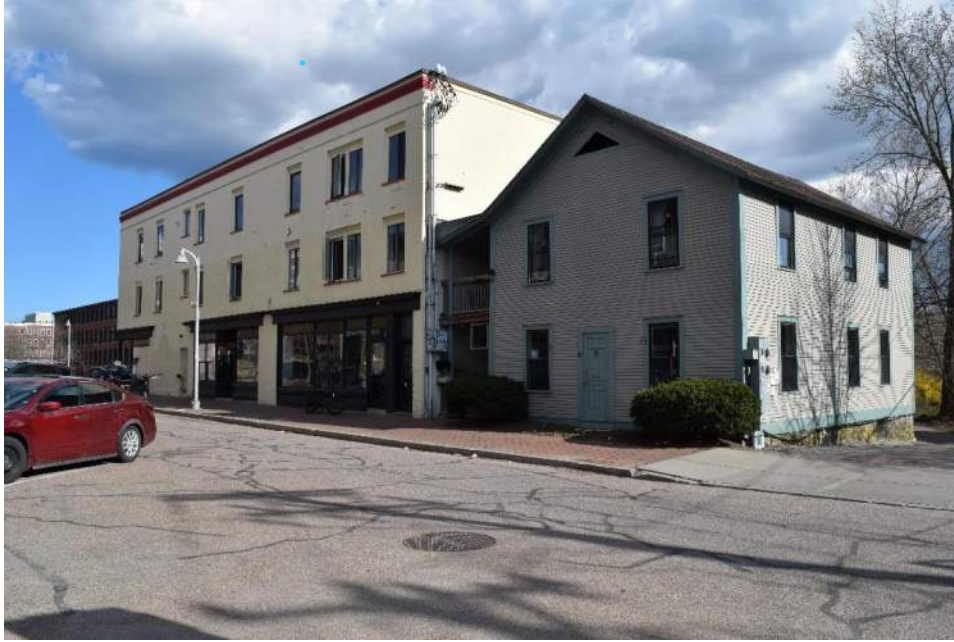
Photo 132: 10 West Canal Street (left). Map ID 111.

132	10 W Canal St (also 22 Main Street)	c. 1845	3 story, 3x7 bay, masonry, flat roofed, commercial building. Multiple commercial storefront entries on Main and West Canal Street. Entries have plate glass windows and doors. Stone foundation, brick walls and flat membrane roof. Brick corbelling near the roofline. Aluminum windows. Also 22 Main Street. Mandarin restaurant.	Winooski Falls Mill HD #5	Remains eligible (listed).
112

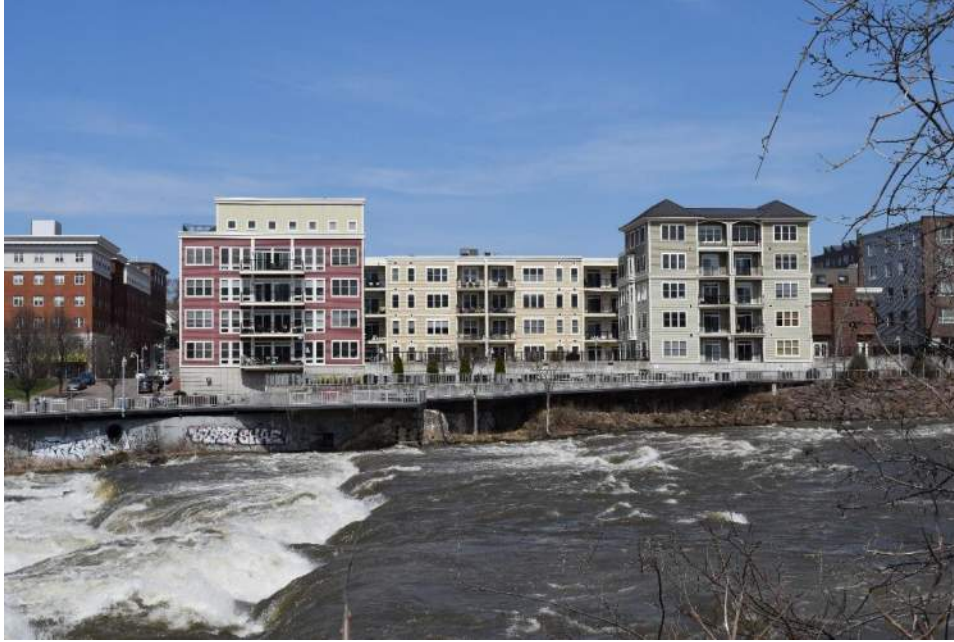
Photo 140: 60 Winooski Falls Way. Map ID 116.

140	60 Winooski Falls Way	c. 2005	Large U-shaped condominium complex. Complex is between 4-5 stories tall. It has a concrete foundation, vinyl siding, standing seam metal and membrane roof. 1/1 vinyl windows. Recessed balconies with sliding glass doors.	N/A	Ineligible due to age
